RDEK ELK RIVER PRIORITY FLOOD AND EROSION MITIGATION SITES

CONCEPTUAL DESIGN REPORT

MAY 2016

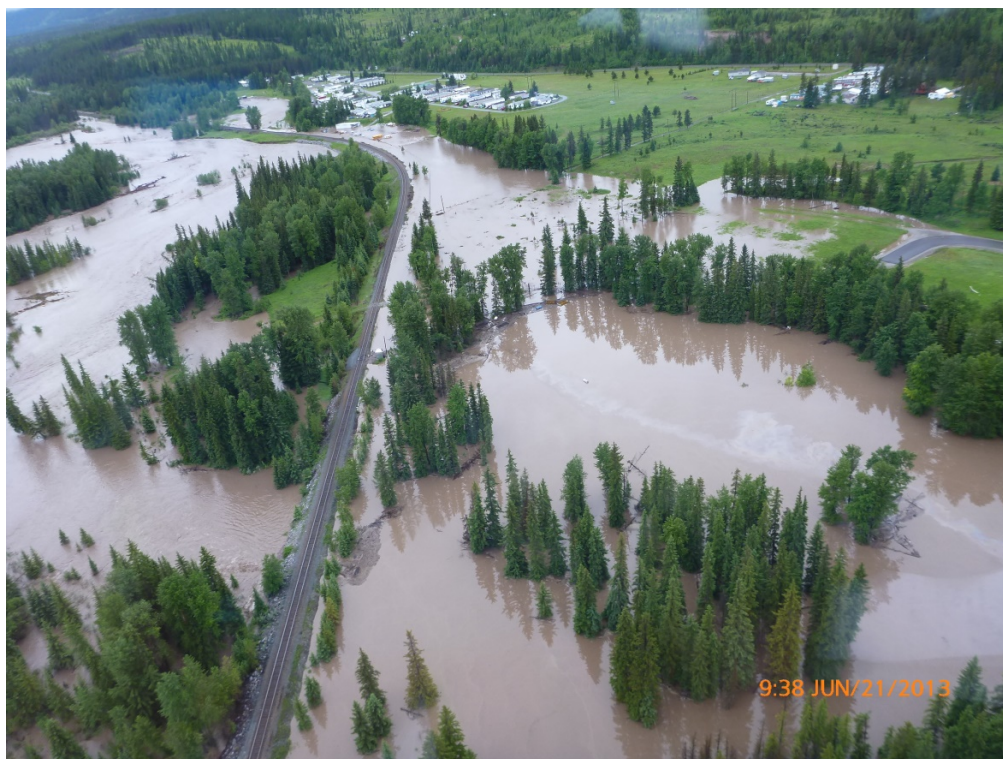
Whispering Winds is located on the west floodplain of the Elk River and is separated by the Elk River by the CP Rail line. Review of air photos found that the area in between the trailer park and the CP Rail line was flooded. However, most of the trailers were outside of flooded areas. Given the magnitude of the 2013 flood and the fact that much of the trailer park was not flooded, this site is considered lower priority relative to the other sites listed in this report. Furthermore, having the CP Rail line in between the trailer park and the Elk River provides protection against other flood related threats, such as bank erosion.

While from this review it does not appear that any flood mitigation here is urgent, it must be noted that the trailer court is mapped within the province's Flood Hazard area. This means that a risk of flooding does exist for the Whispering Winds trailer park. If additional investigations were of interest, then the RDEK could work to more accurately identify the source of flood waters threatening the trailer park. For example, several side channels exist upstream of the trailer court where the CP Rail line is on the opposite (i.e., east) side of the river. These channels present flow paths that could convey Elk River flood water along the west side of the CP Rail line. This water appears to have backed up behind the rail line during the 2013 flood and caused water to flood near the trailer court. A combined approach of a dike protecting Whispering Winds and improved flow under the tracks may reduce ponding and reduce the flood risk for Whispering Winds. Additional investigation can be completed if the RDEK elevates the priority of this site.

Figure 2. Whispering Winds Trailer Park during June 2013 flooding (Source: RDEK).

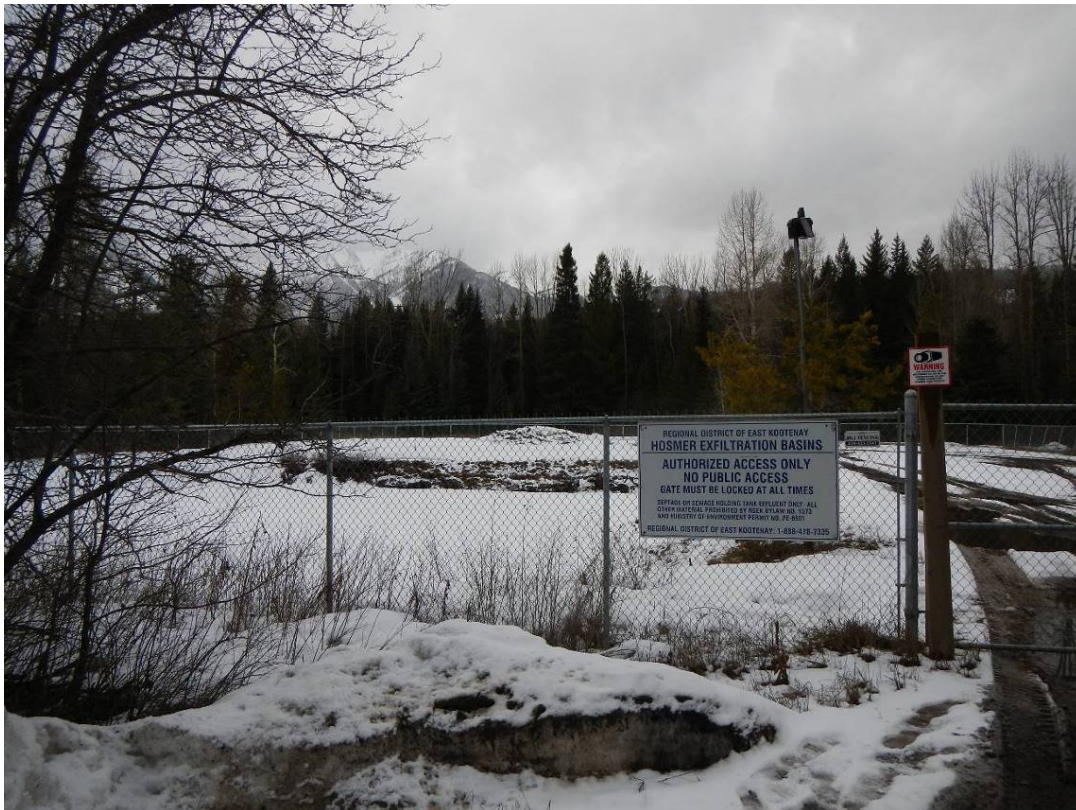
The Ponds are located 300 m from the Elk River and are considered to be within the erodible corridor of the Elk River. This site is also within the riparian zone of the Elk River. Combined, the ponds plus the access road have a footprint of approximately 0.4 ha. While not considered to be at immediate risk, the Ponds are located such that future channel movement may put them at risk of being flooded and/or eroded by the Elk River.

The RDEK conducts routine groundwater monitoring at this site (Ecologic 2015). Monitoring found that conductivity, chloride, and nitrates were higher downgradient of the ponds. This suggests that some groundwater contamination may be occurring. However, dissolved metals met working provincial water quality guidelines (Ecologic 2015). Further investigation prior to site decommissioning will be required.

Figure 3. Hosmer Exfiltration Ponds site photo.

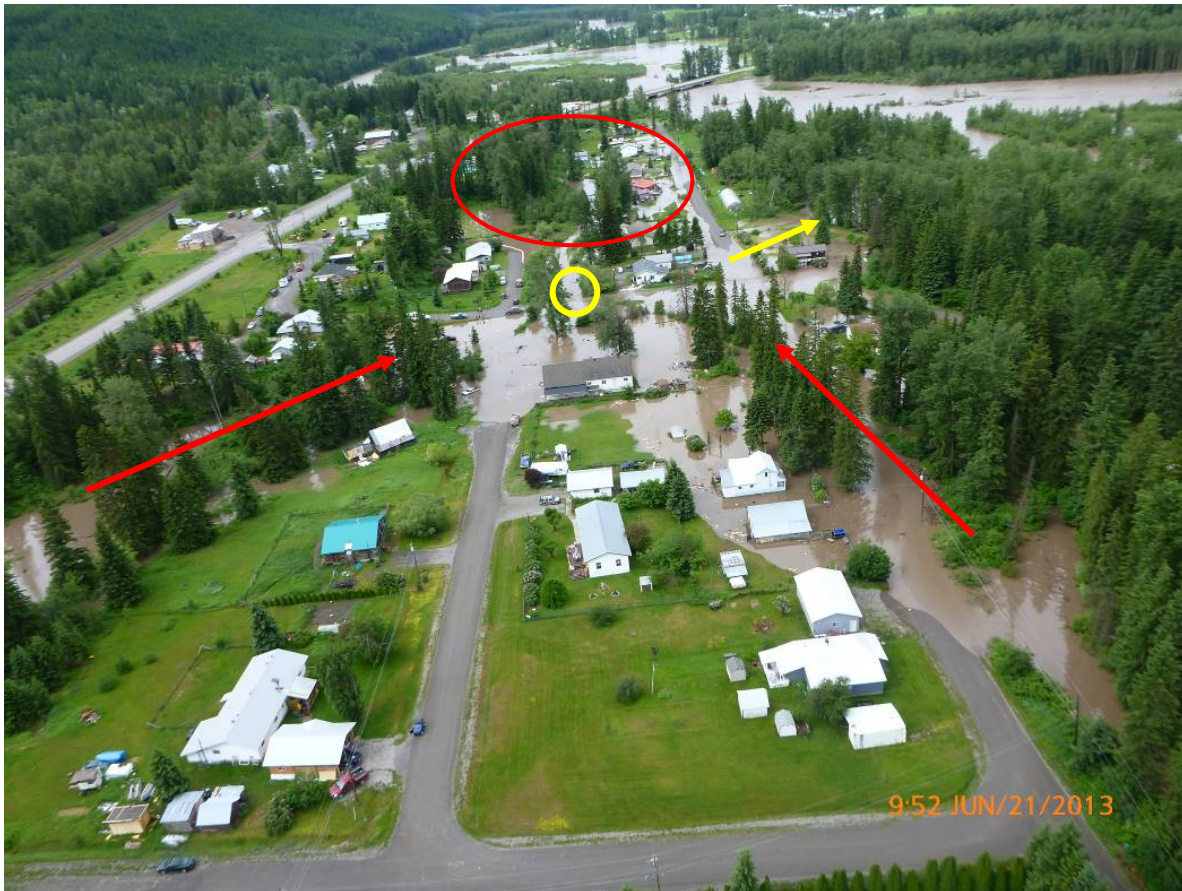
Air photo interpretation best explains the current understanding of flooding in lower Hosmer. Figure 7 shows a downstream (south) view of lower Hosmer during the June 2013 flood. The two red arrows show the left and right braids of Mine Creek as it flows into lower Hosmer. The yellow circle shows the culvert crossing location of Mine Creek and Main Street. This structure appears to have been incapable of conveying the flood flows. It caused water to back up behind the road prism, flooding the houses upstream of the road. Flow on the right side of the photo (yellow arrow) shows where Mine Creek water is suspected to be flowing back to the Elk River, and not the Elk River flowing into lower Hosmer. Further downstream (red circle) there is substantial flooding near the confluence of Mine Creek and Hosmer Creek.

Figure 7. Flooding in Hosmer on June 21, 2013 (looking south). Mine Creek is indicated by the red arrow (Source: RDEK).

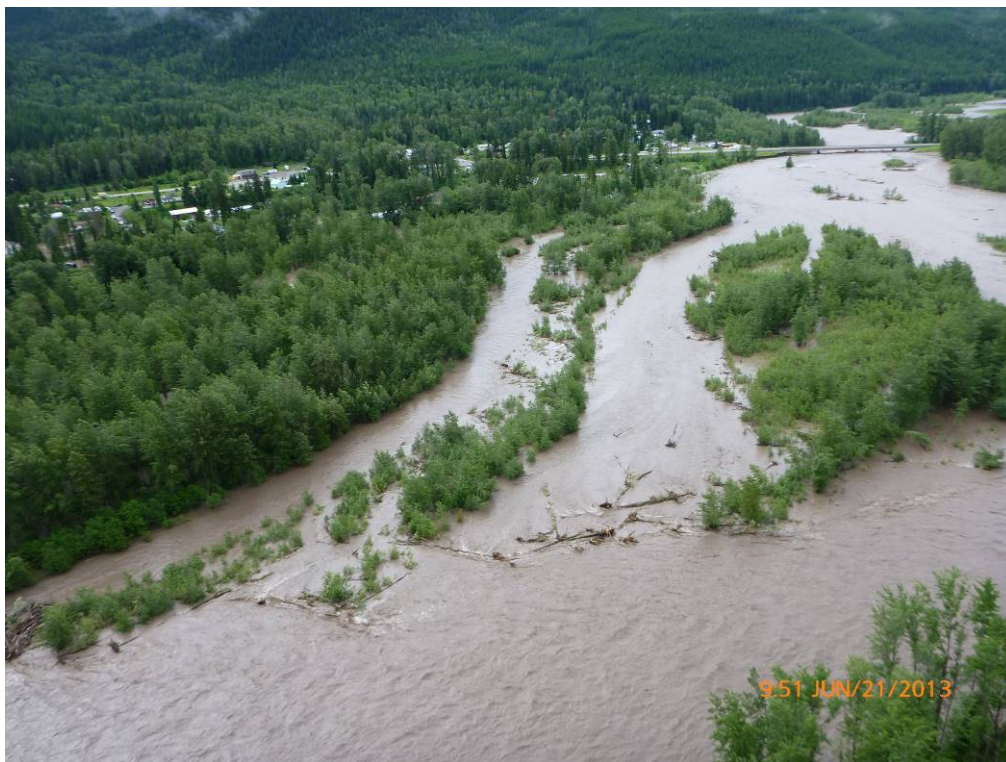
An additional factor that should be investigated is the role that the Highway 3 bridge crossing may play in flooding of Hosmer. Observations of channel morphology at the bridge crossing suggest that this structure may be backing up water during high flow events, resulting in higher water elevations near Hosmer than might occur naturally.

Figure 8. Downstream view of wide flooded area backwatered by Highway 3 (Source: RDEK).

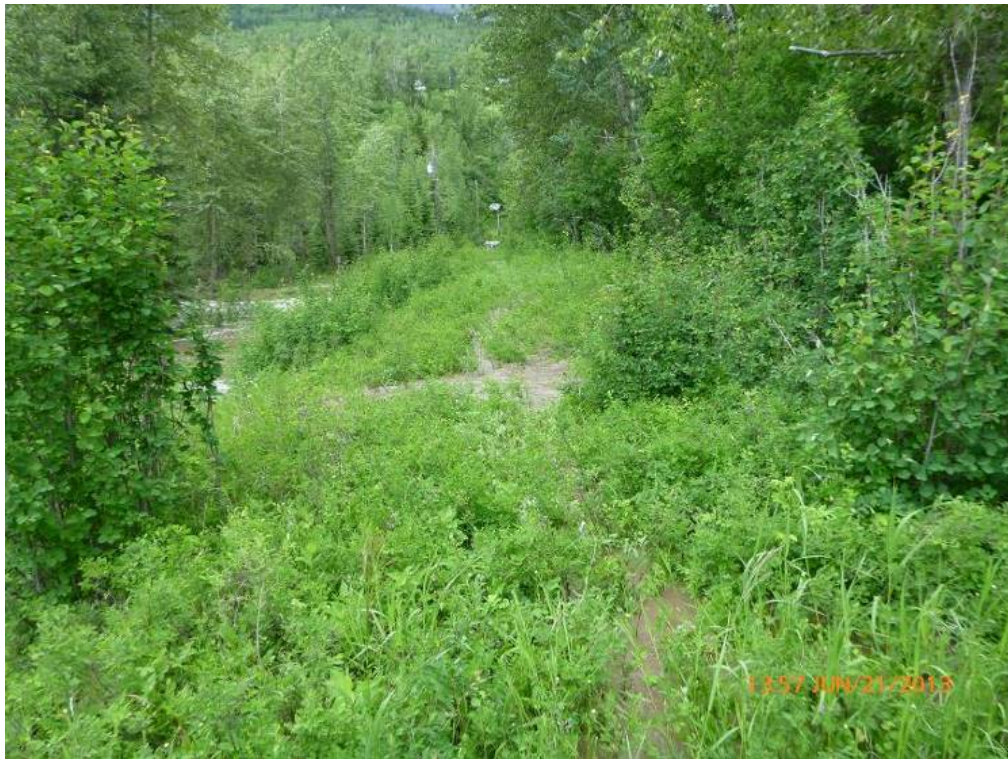
This dike partially failed in 2013 (Figure 11) and resulted in some flooding of downstream properties, including a trailer park with multiple residents (Figure 12). Some emergency works were done in 2013 to stop water from flowing over the dike. Reconstructing this dike (set back as far from the river as possible) would help minimize flooding of nearby properties. Relocating the dike to the upstream side of the two properties currently unprotected, would extend protection to additional land. The objective of the RDEK for this site is to reduce the flood hazard for the private lands to the south and possibly north of the dike structure.

Figure 11. Water overtopping dike in June 2013 (source: RDEK).

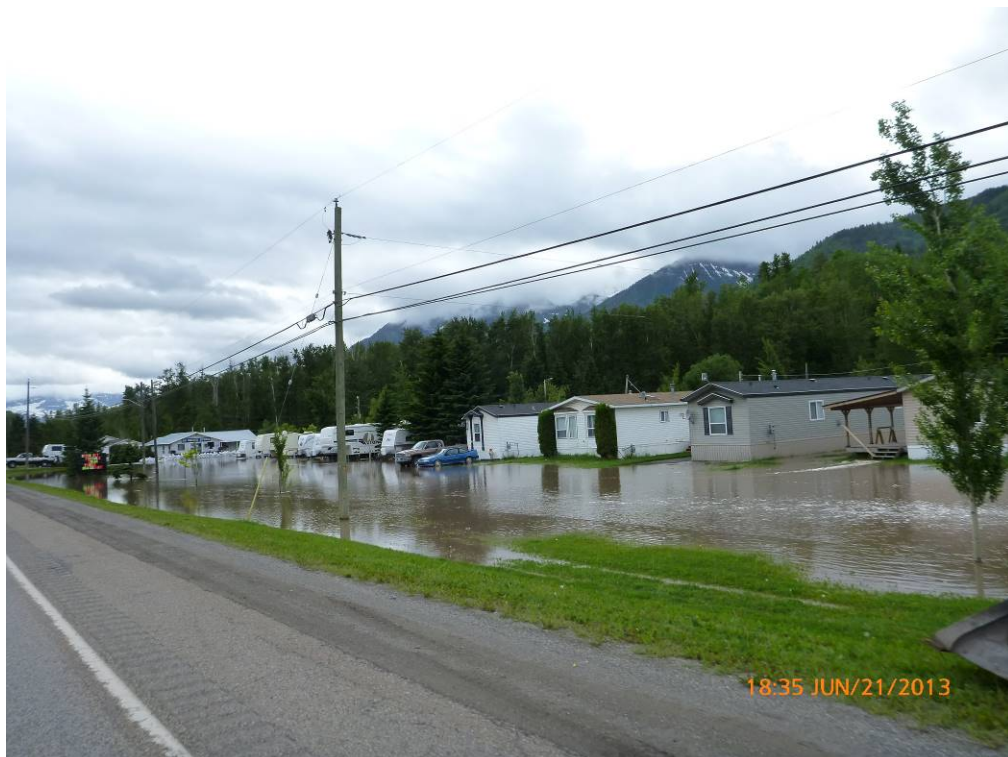
Figure 12. Downstream trailer park and multiple properties affected by the June 2013 flood event.

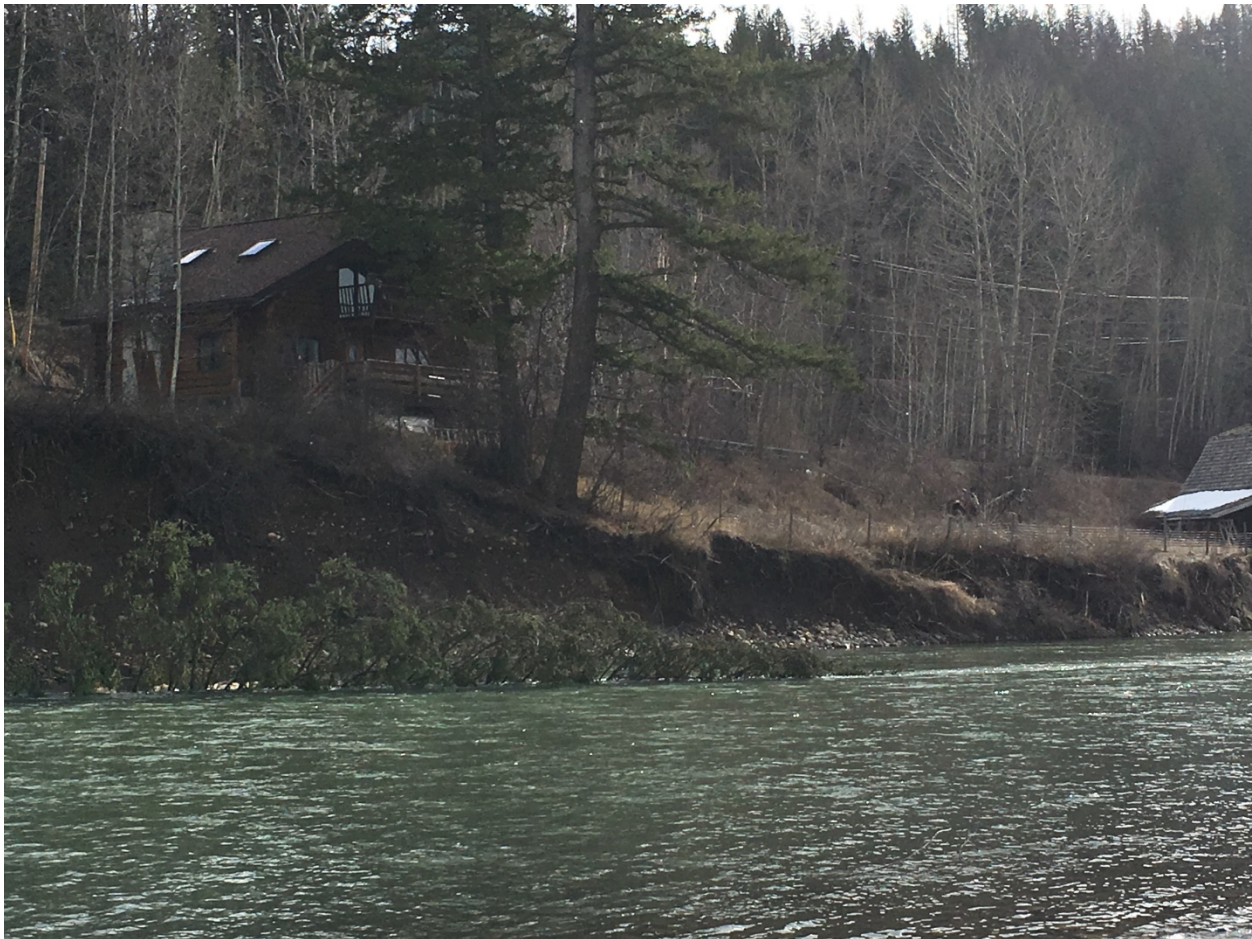
This property is mapped as having approximately 400 m of water front. Bank erosion is occurring along the entire property and is particularly noticeable at the primary residence where an eroding bank approximately 4 m high was observed. Much of the riparian area has fallen into the river as the bank eroded.

Figure 14. Downstream view of eroding bank (left downstream bank) and primary dwelling on property.

The concept will be to use a tiered design to offset some of the impact that meeting this objective will have on channel morphology (Figure 16). The tiered design would begin at the streambed with a keyed in toe similar to a traditional rip rap design (Appendix 1). The rock would extend upslope to an elevation near or slightly above bankfull levels, where a floodplain bench would be constructed. We recommend that a 2 m wide floodplain bench is constructed over the entire 150 m site (i.e., the bank nearest the log home on the property), for a floodplain bench of 300 m². The core of the bench would be constructed of coarse material that will not avulse when overtopped by flood flows (approximately 1-in-2 year to 1-in-5 year return). It would be capped with a growing medium capable of supporting vegetation. Planting can be completed as a combination of grass seeding and live staking (e.g., willow and dogwood species). The slope up from the floodplain bench to a design elevation determined by the project engineer would be treated by constructing a vegetated geogrid (Appendix 2). The bank will first be resloped. The slope of this would be determined in subsequent design phases, but typically a final slope of 2:1 is desired. Successive horizontal benches parallel to the stream are excavated where cuttings will be set in. Benches are to be spaced 1 m apart, with the first located at or near the floodplain bench. The number of benches is determined by the bank height. Benches will be spaced at 1 m slope distance. Cuttings are placed on the benches and covered with a thin layer of growing medium. Coconut coir matting is placed in the trench, backfilled and ran upslope to key into the next bench in sequence or a top trench if it is the upper most layer. Live stakes can be used to hold down the jute and to provide vegetation cover. The area is lastly seeded with an applicable grass seed mix. The top of this slope would tie into existing ground, effectively advancing the toe into the stream from its currently location. This concept assumes two brush layers in the geogrid on average.

The intent of this design is to provide a vegetated buffer along the channel, while meeting the objective of limiting further bank erosion. The tiered approach provides immediate protection while allowing the upslope area to become revegetated. One limitation to this approach is that the upslope area will be somewhat vulnerable to erosion immediately following construction, but will improve as vegetation establishes over time.

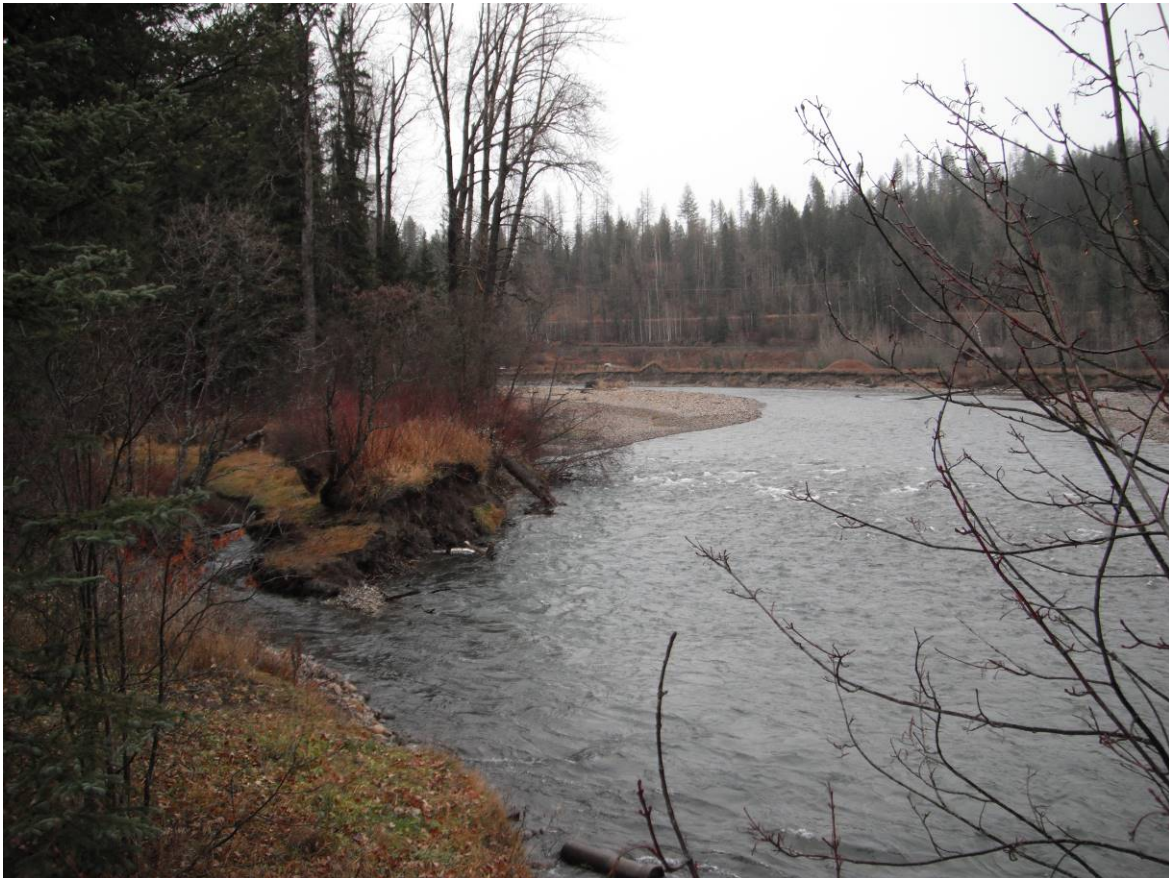
The Elk River is causing bank erosion along two properties located at the end of Vanlerberg Road. The site is at a point on the outside of a slight meander bend. The lateral erosion to the west is creating an issue with the private land upslope. It is understood that flooding is not a concern at this site. This site was listed as a priority as it was an area known to have issues in the recent flood events. The objective for this site is to reduce the rate of bank erosion on the west bank (i.e., right downstream).

The Elk River flows across the channel from the left bank to this site on the right bank. It flows into the bank at Vanlerberg Road at a moderate angle at the upstream end of the site. It then flows parallel along the bank and the subject property at risk to continued erosion. The area has existing habitat value in the form of riparian vegetation. Any proposed project should work to maintain and enhance this aspect of the site. No houses were considered to be in immediate danger of being lost due to bank failure from continued erosion.

Figure 17. Upstream view of Elk River migrating towards private land on the right downstream bank (left of photo).

The concept at this site is to reduce the risk of property loss created by the current bank erosion by limiting further lateral movement of the Elk River to the west. The channel is narrow at this location; therefore, a tiered design similar to that recommended for the Elk River near Mt. McLean Street was not considered to be optimal. Employing a similar design at this location would require shifting the toe into the channel to an extent that it may likely create erosion issues on the opposite bank (left-downstream bank) downstream of the site. As such, a more traditional bank armour design would be recommended at the upstream end of this site, and a bioengineered bank where flows run parallel the bank at the lower end of the site. Note, bank protection is considered to be a short to- medium-term solution that requires maintenance.

Rip rap bank armouring will be installed to protect the toe of slope and bank and for the upper 50 m of the site. We recommend vegetated riprap to reduce the impact of the treatment by providing some habitat value and to improve riprap stability as the shrubs establish overtime (Figure 19). We estimate that the vegetated 50 m along the bank and run 2 m upslope above the bankfull elevation at a slope of 2:1 for a slope distance of 4.5 m. It would be approximately 1.5 m thick. Riprap limits, sizing, and thickness would be confirmed during a hydraulic assessment in subsequent stages. Vegetated riprap is constructed with live cuttings installed as brush layers among the riprap slope. Cuttings are placed in sona tubes filled with a growth medium and protected by a layer of strand board on the upslope side. The proposed design will have two brush layers over the slope of the riprap.

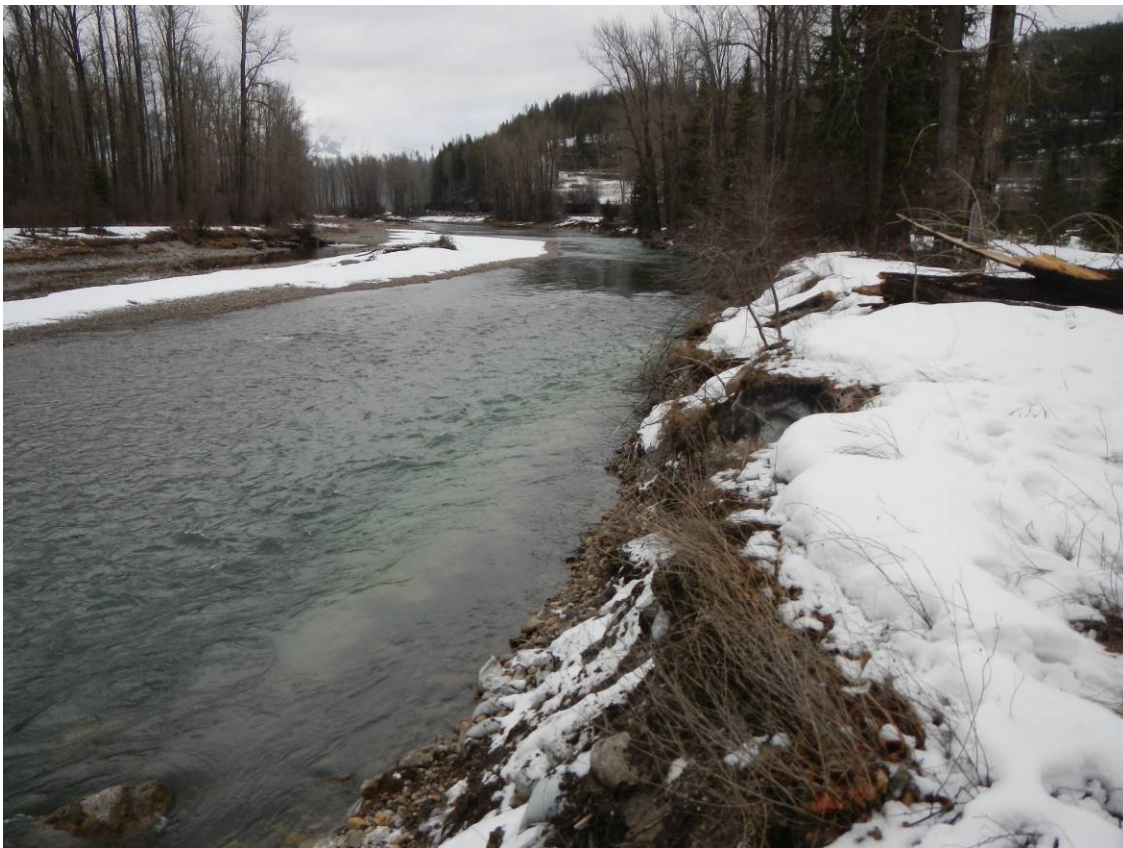
In 2013, an existing dike was eroded and lost along with a large portion of the bank and mature cottonwoods. Until the dike was lost it did provide some protection from flooding to the properties on Hill Road. In early 2014, a low, non-engineered berm was constructed on the southern-most of the two properties. In 2015, Disaster Financial Assistance funds were used to reconstruct the dike that was lost in the flood. This dike was not armoured, nor was the bank below it. The 2015 dike was constructed set back from the top of bank to spare the remaining riparian vegetation and to allow space for riprap to be placed in the future. A section of bank armoring was also completed at the upstream limit of this site. This work was completed by Canadian Pacific Railway (CPR) to protect a section of railway track that is approximately 120 m long.

Figure 21. Upstream view of eroding bank and existing riparian area at Hill Road.

The objective for this site is limiting bank erosion. To do so, the current lateral migration of the Elk River must be restricted. We recommend using a tiered design to offset some of the impact that meeting this objective will have on stream morphology. This concept is similar to that proposed for the Elk River near Mt. McLean St (see Section 7).

The overall site length is 475 m from the existing rip rap bank constructed by CPR to a point downstream of the second subject property. The tiered bank protection would be constructed over this entire length. A rock toe would be constructed to extend from the stream bed to an elevation near or slightly above the bankfull level where a floodplain bench is constructed. We recommend that a 2 m wide floodplain bench is constructed over the entire 475 m long site, for a floodplain bench of 950 m². The core of the bench would be constructed of coarse material that will resist erosion when overtopped by flood flows. It would be capped with a growing medium capable of supporting vegetation. Planting can be completed as a combination of grass seeding and live staking (e.g., willow and dogwood species). The slope up from the floodplain bench to a design elevation determined by the project engineer would be treated by constructing a vegetated geogrid (Appendix 2). The intent of this design is to provide a vegetated buffer along the channel, while meeting the objective of limiting further bank erosion.

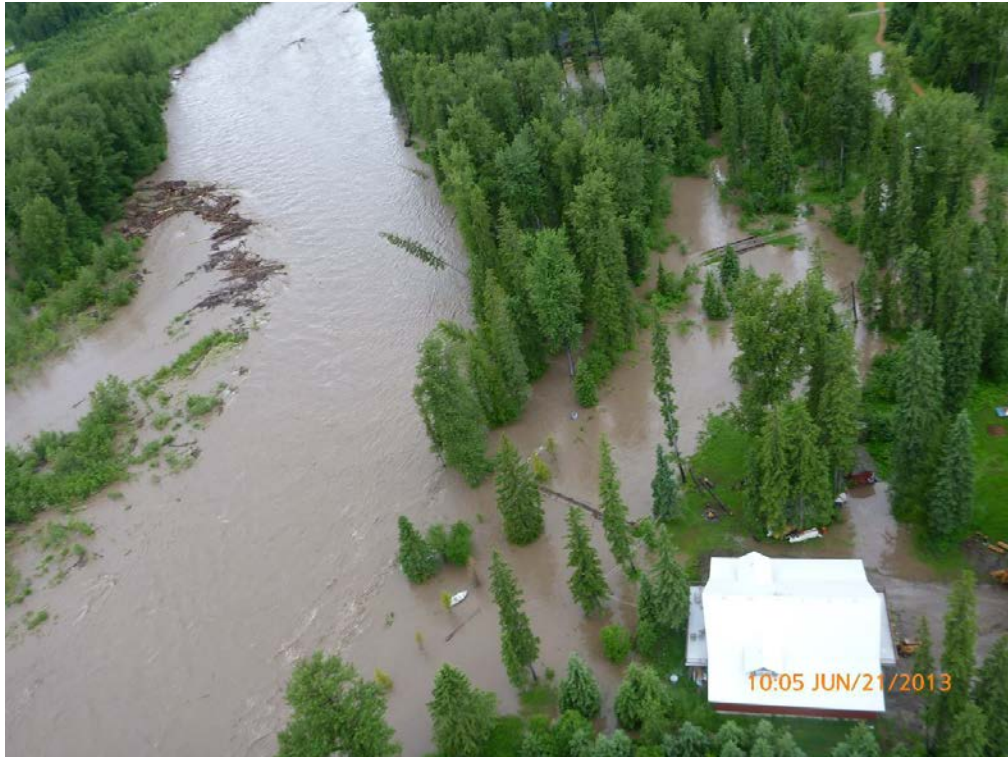
Figure 24. Properties adjacent the Elk River along Thompson Road during the June 2013 flood.

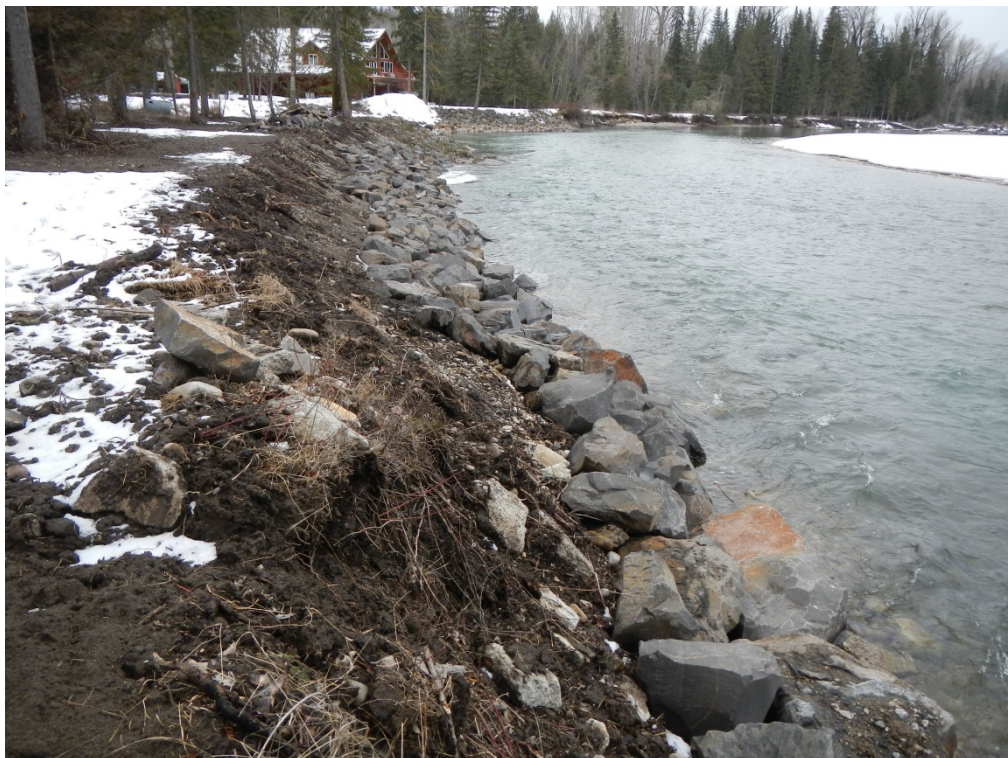
The Thompson Road area was visited in November 2015 where the RDEK identified one property in particular where the landowners had expressed concern of bank erosion. Observations found the area to have already been addressed through rip rap armouring being placed over the slope (Figure 25). Bank armouring had been completed over a section of the left bank that extended for approximately 120 m, ending at a residence within 30 m from the bank. The section of bank was bisected by a relict flood channel flowing in from the east. Given that instream work has already been done to armour the bank in this area, it may be that this site is at low risk (assuming it was done adequately). However, if the RDEK wishes to investigate this site further, then the initial design and as-built specifications must be reviewed by an engineer to determine if the structure has been constructed properly. For example, a review would look at the rip rap sizing, thickness, filter-fabric or filter rock layer, and keying in of the riprap toe.

Figure 25. Rip-rapping along properties at the adjacent the Elk River along Thompson Road site.

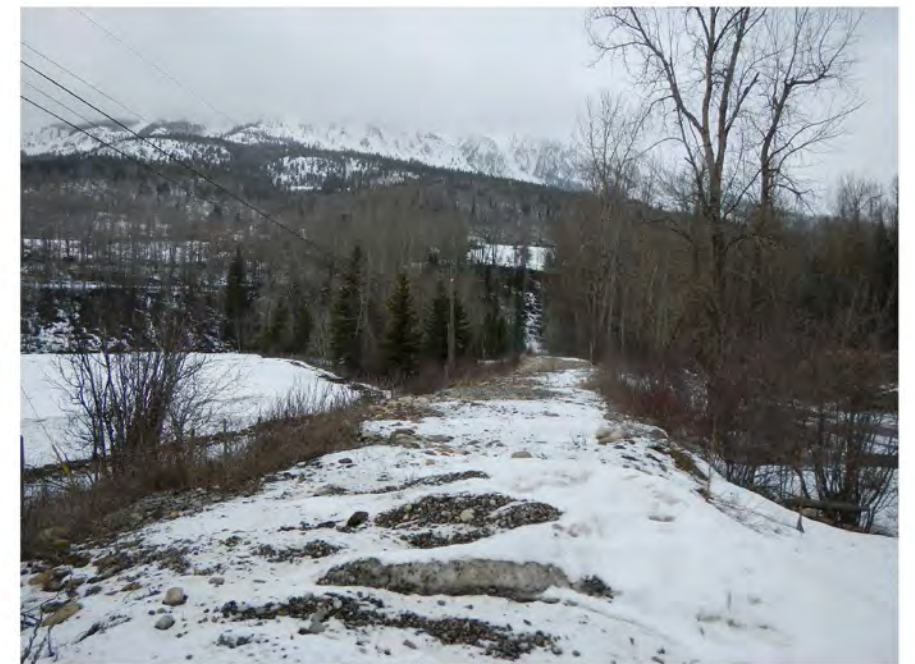
PHOTO 1: VIEW OF EXISTING DIKE FROM HIGHWAY 3.

- 1) BRING EXISTING DIKE TO ELEVATION AS DIRECTED BY ENGINEERING ASSESSMENT.
- 2) ARMOUR UPSTREAM FACE WITH RIP RAP AS DIRECTED IN ENGINEERING DESIGN.
- 3) ENSURE DIKE IS COMPLETE AND NO BREACH POINTS EXIST.

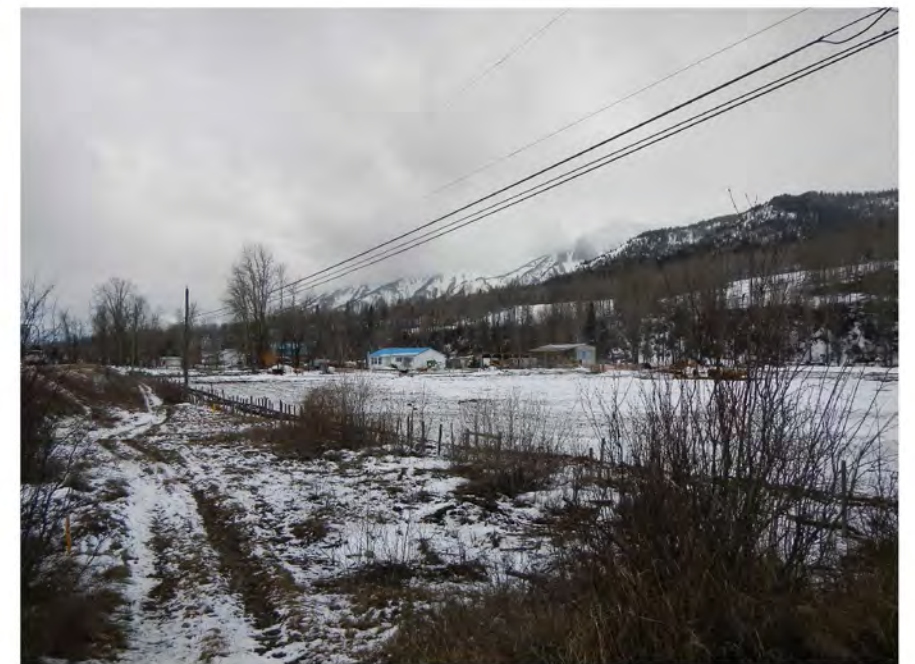
PHOTO 2: VIEW OF PROPERTY AT FLOOD RISK TO WEST OF HIGHWAY 3 AND DOWNSTREAM OF THE EXISTING DIKE.

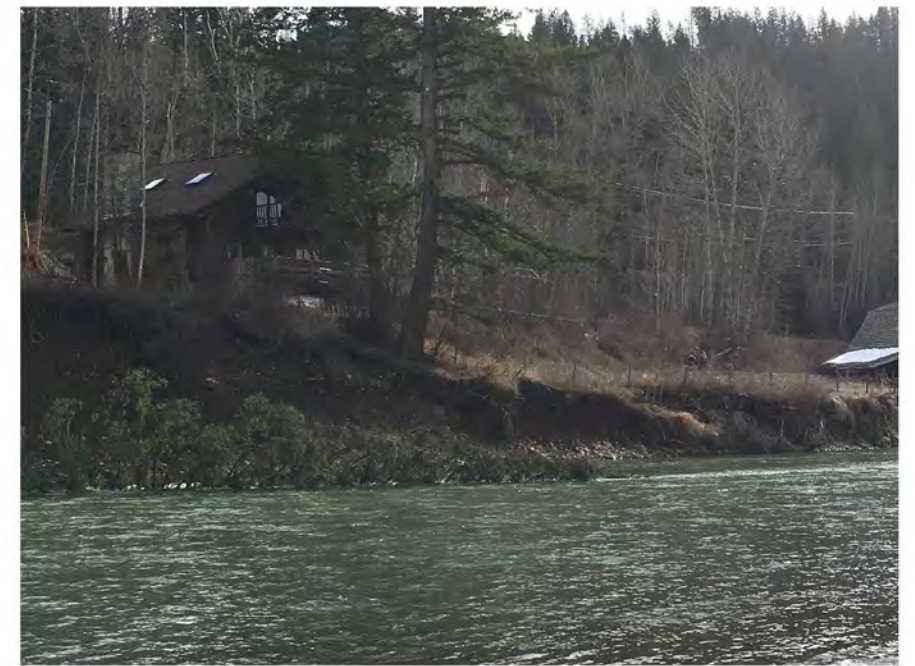
PHOTO 1: DOWNSTREAM VIEW OF ERODING BANK AND HOUSE ON SUBJECT PROPERTY.

- 1) INSTALL RIPRAP TOE AT NEW ALIGNMENT INTO THE CHANNEL TO CREATE FINAL DESIRED SLOPE TIE-IN TO EXISTING BANK.
- 2) BRING ROCK TOE UP TO FLOODPLAIN ELEVATION.
- 3) CONSTRUCT TWO METER FLOODPLAIN BENCH, CAP WITH SOIL, SEED AND PLANT.
- 4) CONTINUE RIP RAP UP SLOPE AT 2:1 TO FINAL ELEVATION.

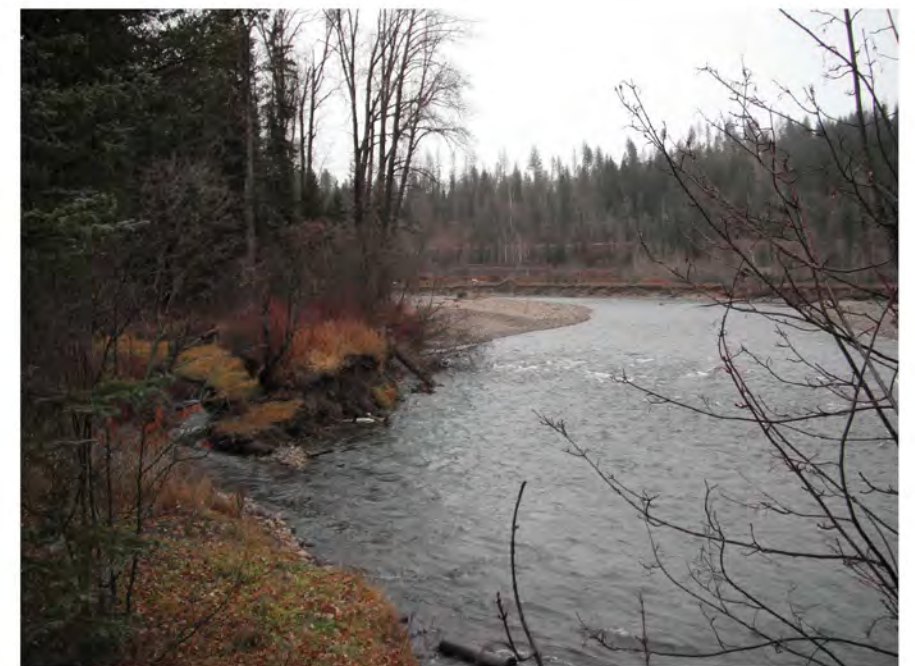
PHOTO 1: UPSTREAM VIEW OF BANK EROSION ON RIGHT DOWNSTREAM BANK (LEFT SIDE OF PHOTO).

- 1) INSTALL RIPRAP TOE TO PROTECT THE RIGHT DOWNSTREAM BANK FROM EROSION.
- 2) CONSIDER TIERED BANK TO INCREASE FLOOD CAPACITY AND PROVIDE VEGETATED FLOODPLAIN BENCH.
- 3) INSTALL ROCK SPURS OFF THE TOE OF THE RIPRAP BANK MOVE THE THALWEG TOWARDS THE CENTER OF THE CHANNEL AWAY FROM THE RIGHT DOWNSTREAM BANK.
- 4) VEGETATE THE TOP OF THE ROCK PLATFORM WITH WILLOW TO PROVIDE FISH AND WILDLIFE BENEFITS.
- 5) ATTEMPT TO MAINTAIN AS MUCH OF THE EXISTING VEGETATION AS IS POSSIBLE.

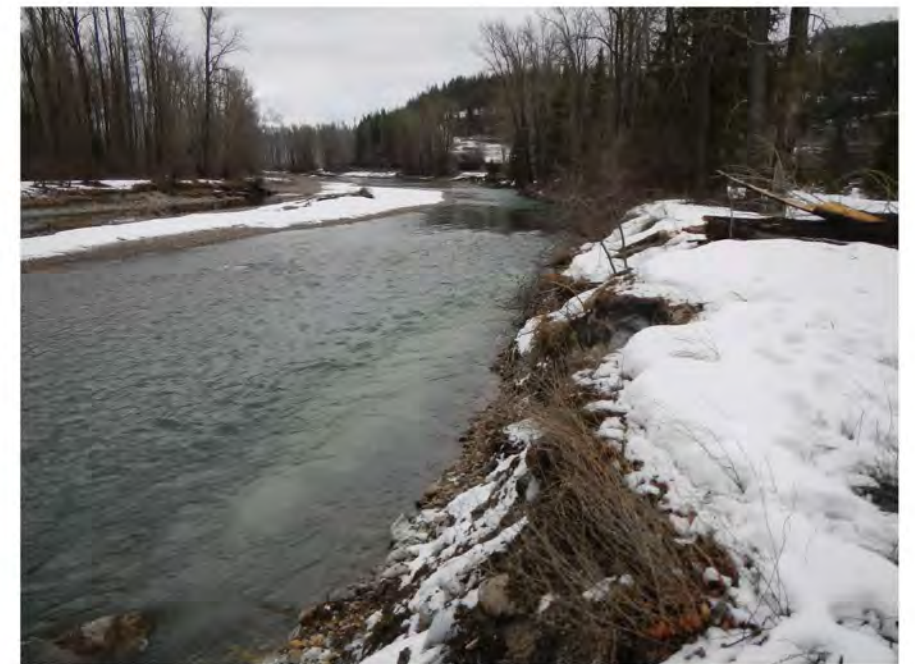
PHOTO 1: UPSTREAM VIEW OF ERODING BANK AND REMAINING RIPARIAN VEGETATION.

- 1) CONSTRUCT TIERED BANK ON LEFT DOWNSTREAM BANK. INSTALL RIP RAP ARMOURING ALONG THE LOWER SECTION OF THE BANK. CONSTRUCT A FLOOD BENCH ABOVE THIS AND VEGETATE. FOLLOW UP WITH A SLOPED BANK THAT MAY BE ROCK ARMOURING WITH A SOIL/VEGETATION COVER.
- 2) PROJECT FOOTPRINT SHOULD EXTEND UPSTREAM AND TIE INTO CPR RIP RAP WORK.
- 3) THE VEGETATION WILL PROVIDE RIPARIAN BENEFITS TO FISH AND WILDLIFE, AND PROVIDE BANK STABILITY.
- 4) CONSIDER ADDING SPURS TO DIRECT FLOW TOWARDS THE CENTER CHANNEL, AWAY FROM THE TOE OF THE RIP RAP AND VEGETATED AREA.
- 5) ENSURE THE DESIGN MINIMIZES DOWNSTREAM IMPACTS ON THE HIGHWAY.
- 6) ENSURE THAT THE WORKS MAINTAIN THE EXISTING COTTONWOOD STAND ALONG RIVER CORRIDOR.

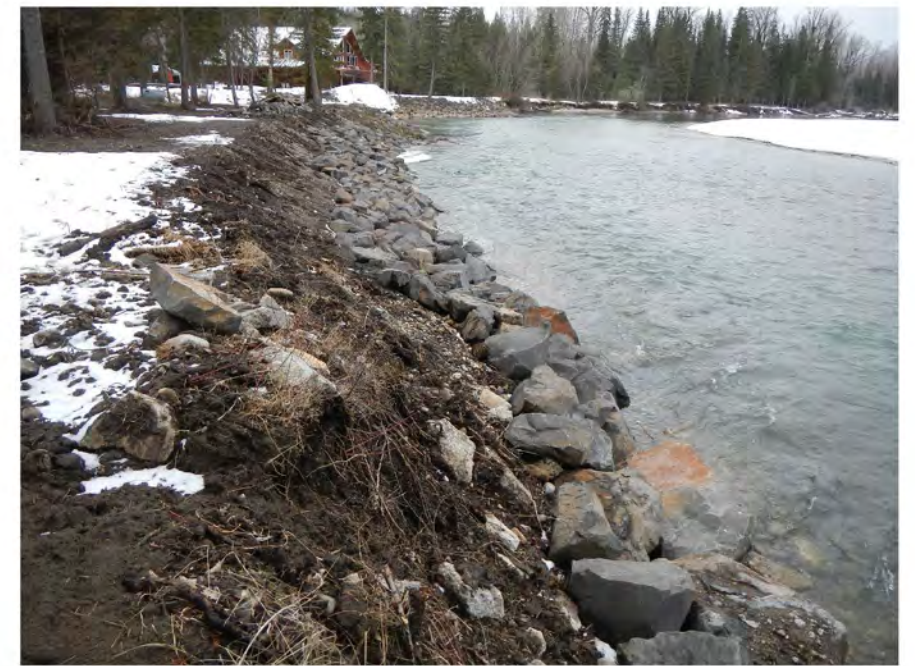
PHOTO 1: DOWNSTREAM VIEW OF EXISTING RIP RAP WORK.

- 1) INSTALL ADDITIONAL LWD JAMS TO ENHANCE EXISTING WORK ALREADY DONE AT THE SITE.
- 2) CONSIDER ROCK SPURS.
- 3) AVOID LWD AND/OR VEGETATION REMOVAL ON OPPOSITE SIDE OF THE ELK RIVER (I.E., WEST SIDE).
