# Alexander Creek Streamside Restoration and Community Education

Project Reference Number UKE-F17-F-1264

Date: 31-03-2017

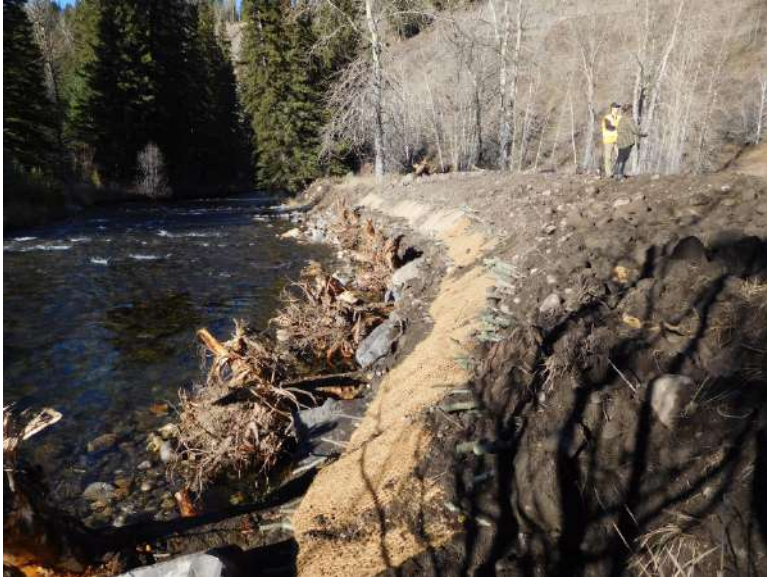
**Figure 23: Completed bank stabilization and slope re-contouring**

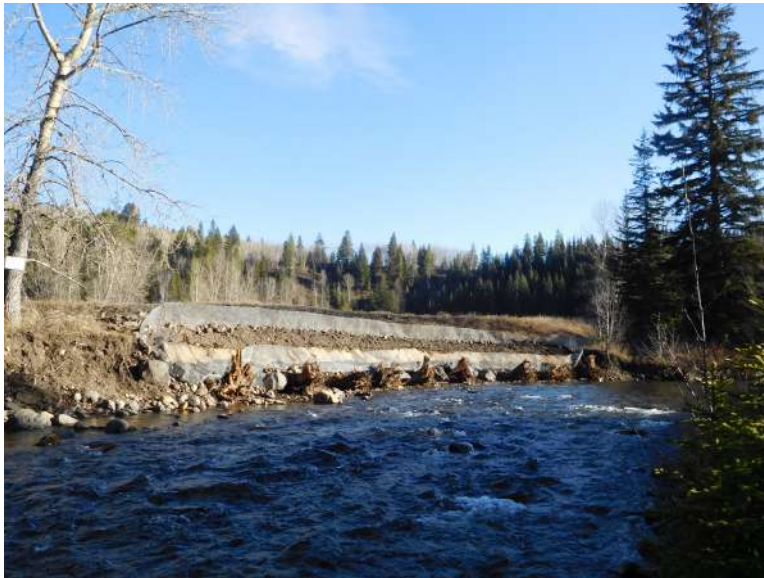
The 600 cuttings were then used to create 2 brush layers to stabilize the streambank. Two footer logs, nine rootwads and a total of 27 large rocks a minimum of 1 m<sup>2</sup> were further used to reinforce the streambank. This will restore a 30 m by 3 m area of eroded streambank (**Figure 29**).

**Figure 29: Completed streambank stabilization project a restoring 30 m stretch of eroded bank**

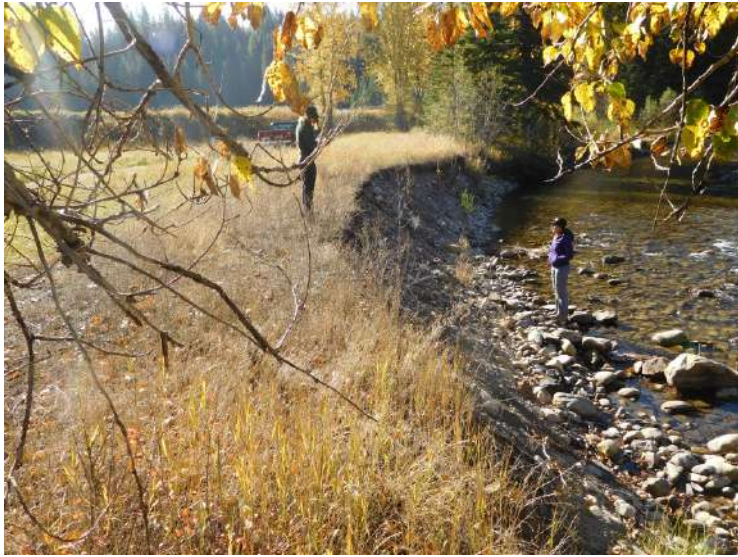
**Figure 34: Photo reference point 1 before prescription**

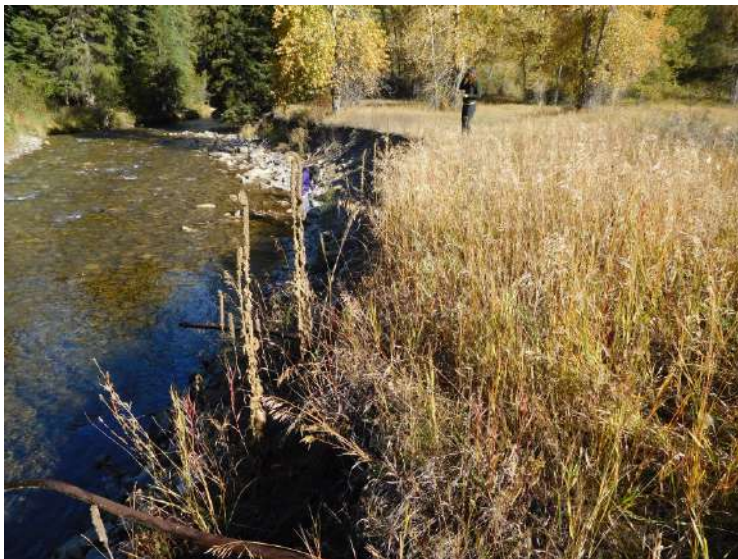
**Figure 35: Photo reference point 2 before prescription**

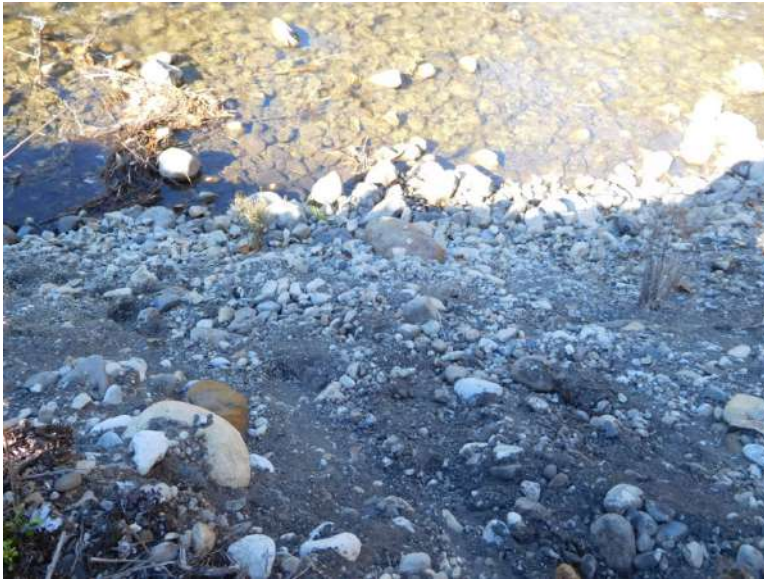
Results from the riparian health assessment for the restoration site landed in the *unhealthy* category with a score of 11%. The vegetative cover of the riparian area was very sparse with mostly cobbles and sand (**Figure 36**). Undesirable species present included spotted knapweed, oxeye daisy and common mullein (**Figure 37**). There was no tree or shrub establishment. There were decadent forbs and grass, but no dead woody material. There was no streambank root mass protection and the bank was heavily eroding. Structural alterations by human activity include levelling and the removal of riparian vegetation due to the construction of a nearby road.

**Figure 36: Lack of creek-side vegetation noted during riparian assessment prior to prescription**

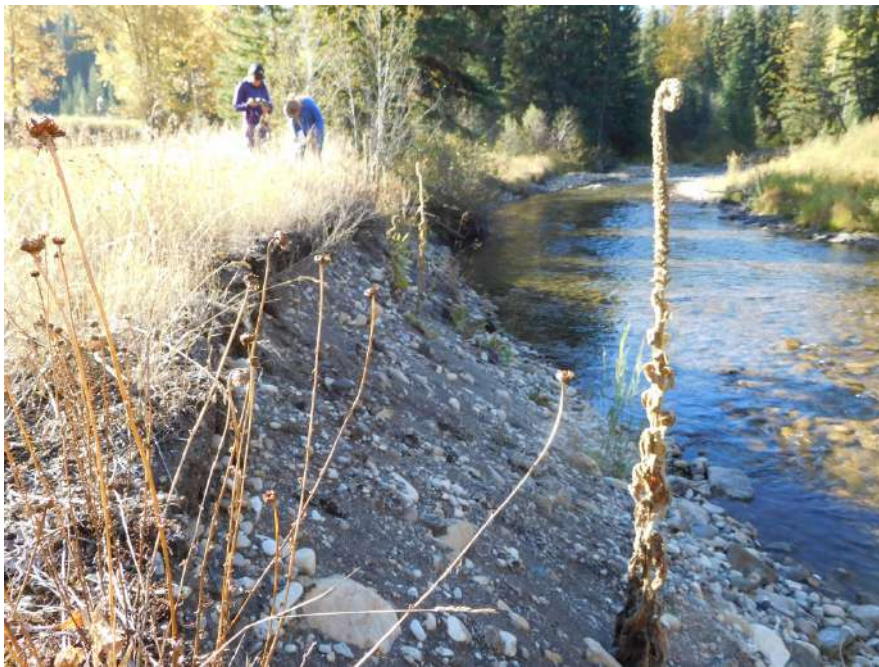
Figure 37: Undesirable vegetative species recorded during riparian assessment

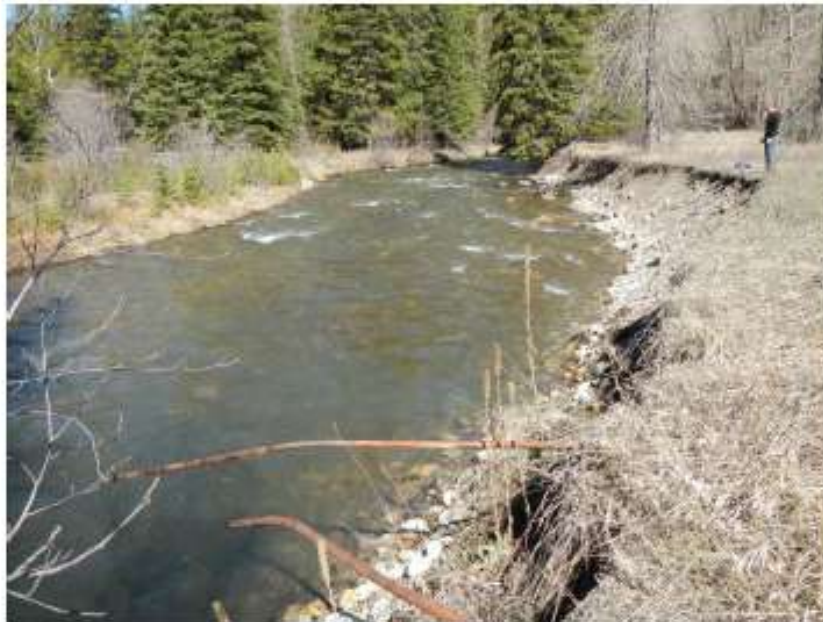
The site showed extensive erosion over 30-40 m in length and a 3 m high bank. The right bank lacked riparian vegetation beyond grasses, which exacerbated the erosion issue. Many invasive weed plant species were also present. Overwidening of the channel was apparent over the length of the site. Because of the previous disturbance in the way of riparian clearing, this site was considered to be an anthropogenic issue resulting in the site not functioning naturally in terms of erosion rates or habitat value. A survey of adjacent, vegetated meander bends supported this claim that the banks of Alexander Creek in this reach are generally more stable than this proposed site.

Figure 1. Downstream view of treatment area.

The recommended rehabilitation objective is to provide temporary bank protection to allow the area enough time to regenerate riparian vegetation in the form of shrubs and trees, thus providing long-term stability. The design concept is to use rootwad revetments to stabilize the toe of slope and use a combination of a vegetated geogrid (i.e., brush layers with coconut coir) and plantings to promote revegetation on the upslope areas. In doing so, a vegetated floodplain bench will be created on the outside bend, further reducing the rates of erosion.
