Sparwood Beaver Wetland Site Report and Health Assessment

Prepared by:
BC Wildlife Federation (BCWF) Wetlandkeeper Instructor – Lee-Anne Walker
&
Beth Millions - Elk River Watershed Alliance, Restoration and Stewardship Program
Coordinator

August 29, 2017

Reed Canary Grass (RCG) Integrated Pest Management (IPM) Sparwood Beaver Wetland

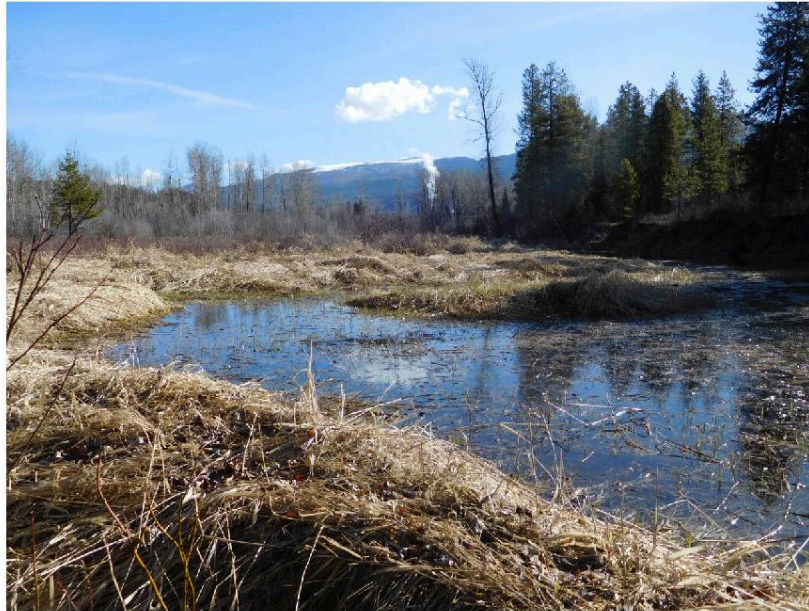
Figure 1. View from the southern edge of the Sparwood Beaver Wetland looking north at the RCG monoculture along the berm. Photo was taken in the spring.
