Elk River Alliance

Coal Creek Cottonwood Project Pilot Restoration Plan

March 2020

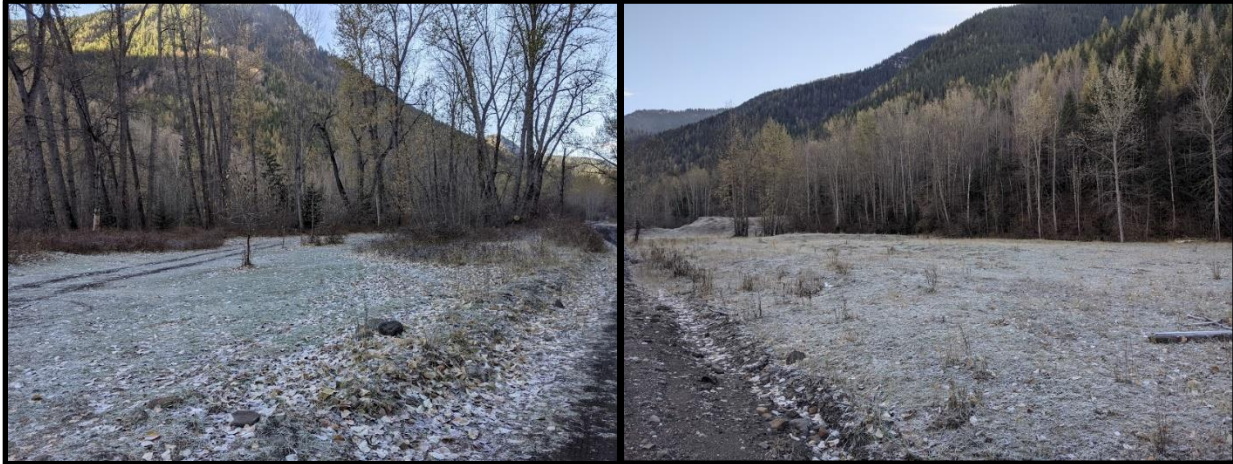
Figure 2: Proposed restoration site. Note lack of native overstorey and understory vegetation, ground compaction and vehicle rutting

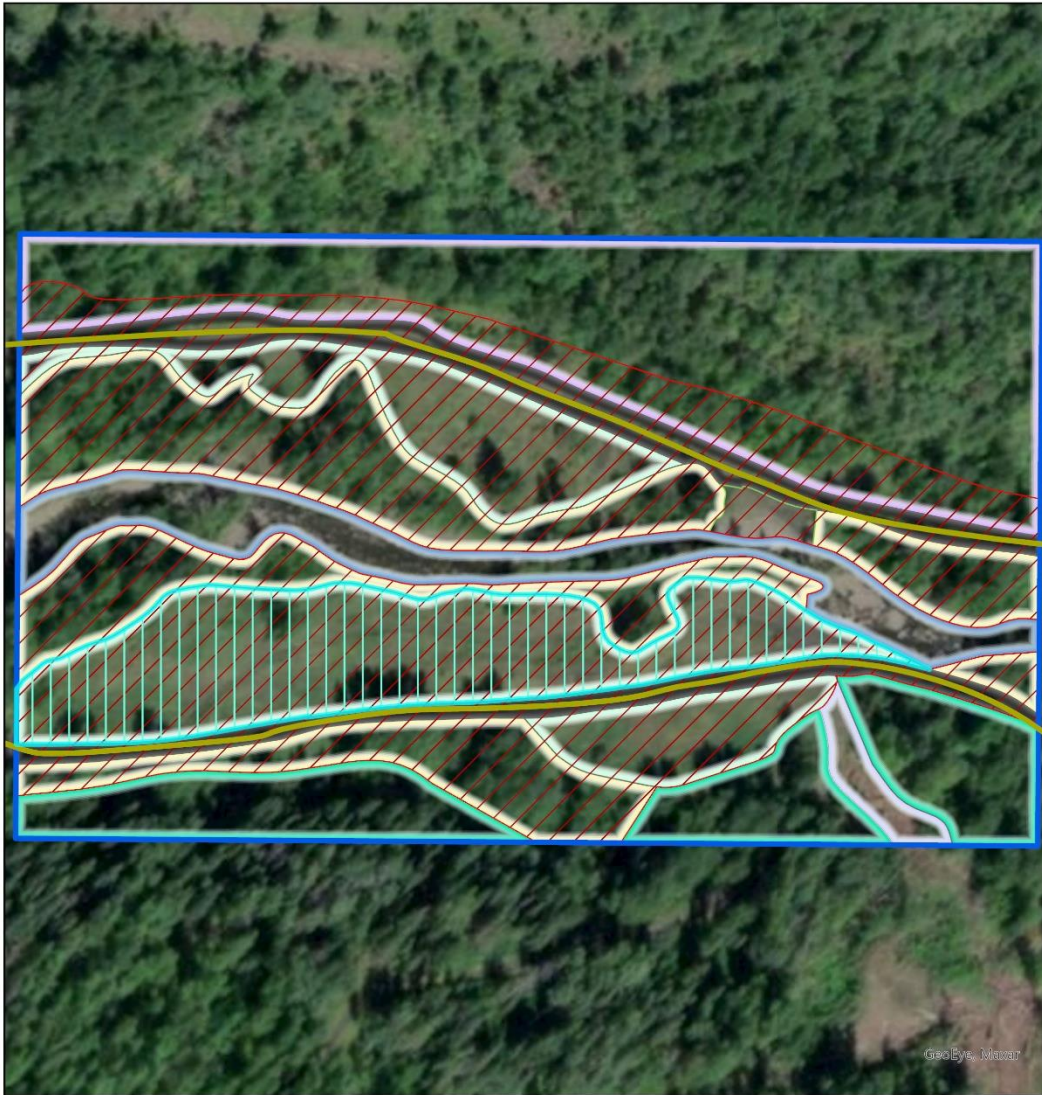
Figure 4: Site map detailing vegetation associations present and proposed restoration activities.

The following vegetation groupings were identified at the site during site inspections. These are mapped in Figure 4. Information for these descriptions was taken from LMH 25 (BC MFR and BC MOE 2010) and LMH71 (MacKillop et al. 2018)

- 111 (CwSxw – Devil’s club):** Spruce (*Picea engelmannii x glauca*) and cedar (*Thuja plicata*) are the dominant overstorey trees, often with Subalpine Fir (*Abies lasiocarpa*). In the understoreys, devil’s club and/or lady fern are typically abundant (> 10%). Black gooseberry (*Ribes lacustre*), thimbleberry (*Rubus parviflorus*), oak fern (*Gymnocarpium dryopteris*), and one-leaved foamflower (*Tiarella unifoliata*) are also common, along with minor cover of false-hellebore (*Veratrum viride*; particularly on colder sites) and stinging nettle (*Urtica dioica*). Leafy mosses and ragged-mosses are usually common and can be abundant.

- **111/At:** Similar to 111 above, on northern side of site. Contains a significant Trembling Aspen (*Populus tremuloides*) component.
- **Fa (Stream Channel):** Active channel ecosystem, includes gravel bar and islands. Often scoured for prolonged periods. Exposed and are usually immediately adjacent to the river channel at lower water levels and under water at high water levels. On unstable substrates, such as gravel bars and islands, Fa ecosystems are usually dominated by opportunistic annuals or perennial herb species with extensive root systems that are able to re-sprout after the aboveground structures have been removed by flooding and scouring. This unit also includes a smaller gravel bar and island component dominated by willows.

- **Fm02 (Fm02 Cottonwood – Spruce – Dogwood):** Black cottonwood is dominant in the overstorey, often with minor spruce (*Picea engelmannii x glauca*), and sometimes with cedar (*Thuja plicata*). Red-osier dogwood (*Cornus serica*) is dominant in the shrub layer and frequently occurs with mountain alder (*Alnus incana*), black gooseberry (*Ribes lacustre*), and/or highbush-cranberry (*Viburnum edule*). Willows (*Salix* spp.) and snowberry (*Symphoricarpos*) are also sometimes common. Horsetails (*Equisetum*), sweet-cicely (*Myrrhis odorata*), and pink wintergreen (*Pyrola asarifolia*) are usually present, often with minor cover of bluejoint reedgrass (*Calamagrostis canadensis*), false Solomon's-seal (*Maianthemum racemosum*), oak fern (*Gymnocarpium dryopteris*), and/or blue wildrye (*Elymus glaucus*).

- **Vt (Avalanche Treed):** A small component of the site includes an avalanche track.
- **Xa (Cleared Area):** Cleared area makes up a majority of the site. This area is utilised as a laydown/staging area by recreationalists and logging companies, and likely an informal campsite. This would be an ideal area for moderate revegetation and restoration of cottonwood forest. However, should revegetation activities occur in this area it is recommended local users be consulted to determine if ongoing recreational or forestry use of the area is anticipated.

- **XaR (Cleared roads):** Two access roads pass through the site. The southern road is a well used forestry road utilized by recreationalists and logging trucks. The northern track is a less utilised forestry/historical road used by recreationalists. Both will be required for site access.

Locations of proposed restoration activities are detailed in Figure 4.
