Silver Springs Backcountry Toilet - Phase 1 Feasibility Study

Prepared for: Province of British Columbia

Prepared by: Beth Millions, MSc Environment Science, Elk River Watershed Alliance
Lee-Anne Walker, MA Environment & Management, Elk River Watershed Alliance

Date: February 15, 2018

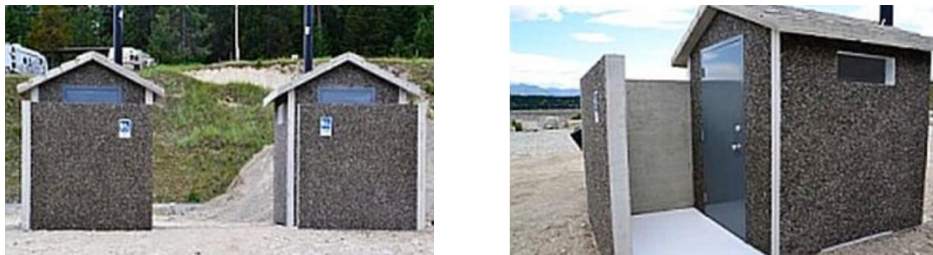
Figure 3. Single stall outhouse units developed by Tri-Kon Precast Concrete Products; photos from <http://www.trikonprecast.com/outhouses>

A vault toilet constructed and installed by Tri-Kon Precast Concrete Products (601 Patterson Street West P.O. Box 491 Cranbrook, BC, (250) 426-8162) is a long-term toilet option. These toilets are commonly used by BC Parks and BC Ministry of Transportation, and have demonstrated professional and durable products that are less susceptible to damage from unruly site users. The initial cost for the structure to be built and installed is \$13, 500, and will require seasonal maintenance ranging from \$150-\$250 per service, depending on the size of the septic tank (quote from Wright’s Vacuum & Septic Service). Further considerations are: septic tank may fill faster, especially if it is used as a garbage receptacle, and may require more frequent emptying; people may still choose to not hike back from the first lake if they need to use a toilet and instead excrete near the first lake.

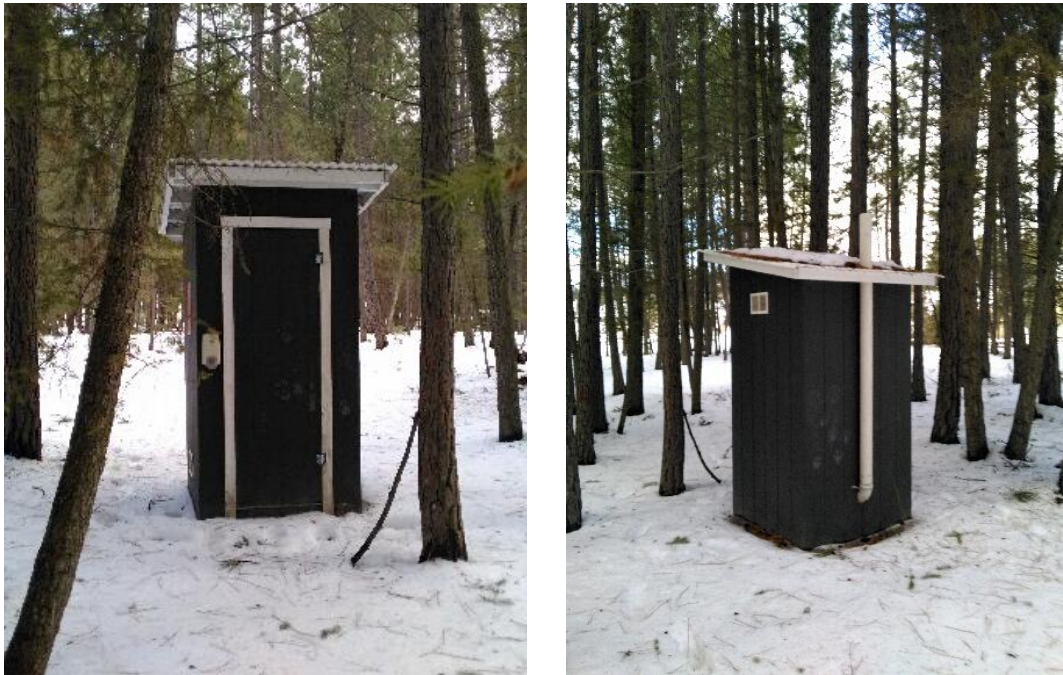
Figure 4. Single stall outhouse unit developed by Beau West Contracting.

A vault toilet constructed and installed by Beau West Contracting (Grasmere, BC, (250) 278-3475) is another long-term option. These toilets have been used by the Ktunaxa Tobacco Plains Band at their Big Springs Campground and have demonstrated durable products at a more affordable price than the first vault toilet option. These products have been designed to be heavy to avoid being tipped over, though one facility was been knocked over from extreme weather conditions that toppled several trees. The initial cost for the structure to be built and installed is approximately \$4000 and will require seasonal maintenance ranging from \$150-\$250 per service, depending on the size of the septic tank (quote from Wright’s Vacuum & Septic Service). Further considerations are: septic tank may fill faster, especially if it is used as a garbage receptacle, and require more

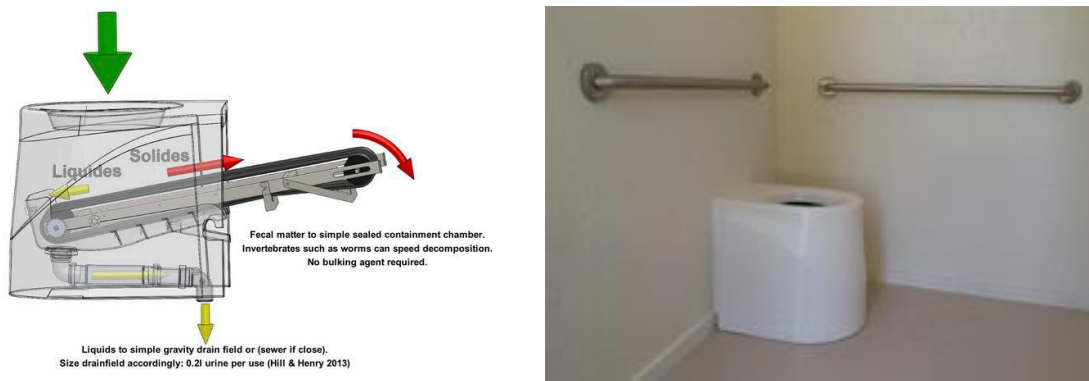
Figure 5. Urine diverting throne developed and distributed by Toilet Tech Solutions; photos retrieved from www.toilettech.com

A composting toilet developed by Toilet Tech Solutions (Scott@toilettech.com, (604) 828-3608, <http://www.toilettech.com>) would provide a long-term, on-site toilet option at Silver Springs' first lake. A urine-diverting composting toilet has demonstrated the ability to most effectively breakdown human waste and is more likely to yield compost when compared to a mixed latrine-style composting toilet, according to the literature. This option will cost approximately \$5000 for the urine diverting conveyor and a throne (see figure 5). It may also require a small platform to be developed upon which it can sit as it would be located on rock that may be uneven. The surrounding building would also be required. This will cost approximately \$1000 for the platform and \$2500 for the structure. All of the components and materials will need to be flown in via helicopter, at a rate of approximately \$600/flight, and will require a minimum of two flights. Two contractors will need to install the unit once it is delivered onsite (see Appendix E for installation guide). Paid at a rate of \$50/hr for one 8-hour day, this brings the total installation cost of \$10,500. Further ongoing maintenance is required, and will likely be above and beyond the quoted amount provided by Toilet Tech Solutions, as the site users are more likely to abuse and vandalize the facility. At a minimum, maintenance will be \$150 a season, but likely more. Further considerations are: the addition of garbage will likely require that the solid waste need to be flown off-site for treatment, possibly once a season; garbage services will need to be provided at the trailhead to discourage people from throwing

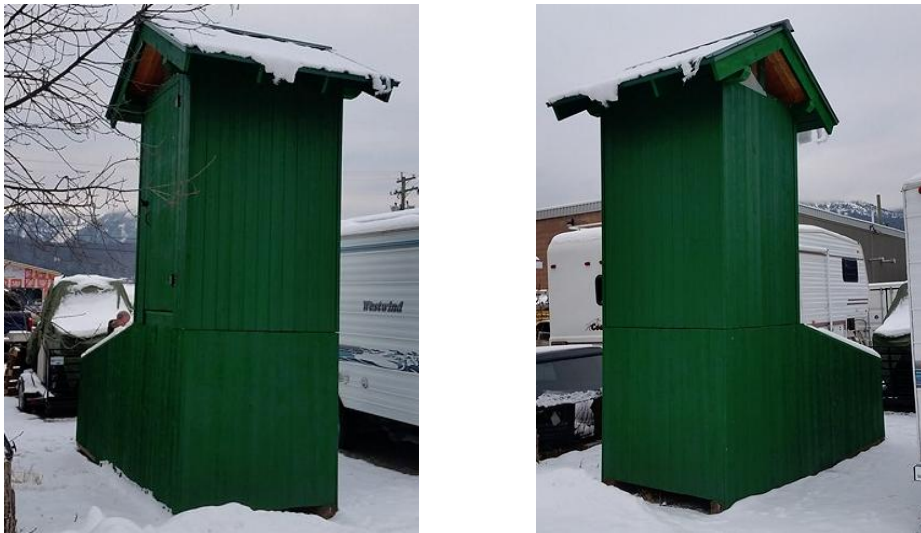
Figure 6. A composting toilet constructed by Stokie Enterprises.

A composting toilet constructed by Stokie Enterprises (Fernie, BC, istokie@yahoo.com, (250) 423-0726) would provide a long-term, on-site toilet option at Silver Springs' first lake. Considered a mixed-latrine composting toilet, this toilet option does not have the same demonstrated ability to effectively decompose high usage human waste and remove pathogens to a safe level, having never undergone the same testing as the first option. However, the material will likely not be able to be disposed of on-site due to the presence of garbage and feminine hygiene products that will likely end up in the facility, so this may not be important. Ian Stokie has monitored the composting toilets installed at Thunder Meadows and Tunnel Creek and has observed significant breakdown at these locations, though no tests have been conducted. It is important to note that if the breakdown of the organic material cannot keep up with the rate of deposition, then this method will likely fill up faster due to the addition of a the bulking agent. This option will cost approximately \$10,000 for the facility. All of the components will need to be flown in via helicopter, at a rate of approximately \$600/flight, and will require a minimum of two flights for a total installation cost of \$11, 200. Further ongoing maintenance is required and, similar to the first composting toilet option, is highly variable as site users are more likely to abuse and vandalize the facility. The minimum

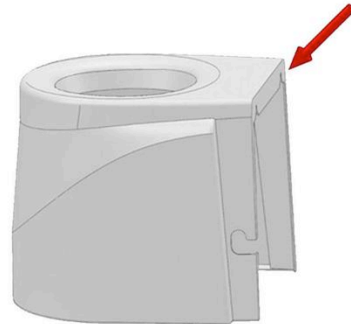
ADJUST THE SEAT AGAINST THE WALL'S SURFACE

You can rasp up until 5 mm on the back of the seat
to adjust its position.

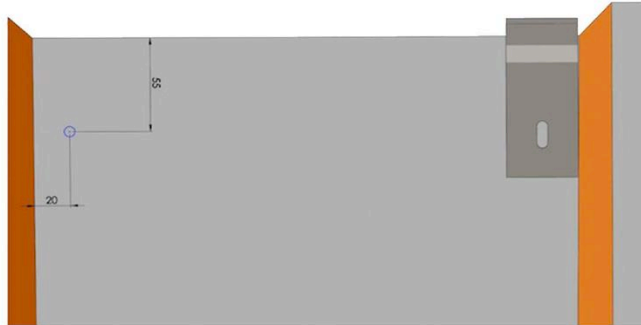
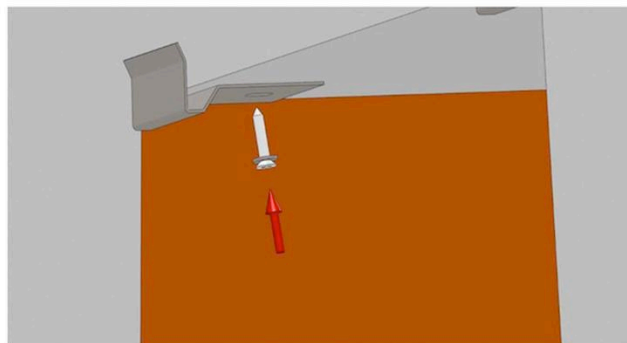
OPTION 2 : for a wall in brick or cement

With a pencil, trace the position of the screws for the hinges on the side of the hole depending on the following diagrams.

Screw the hinges using the oblong hole in order to adjust the position.

The seat should be able to be removed and repositioned without forcing

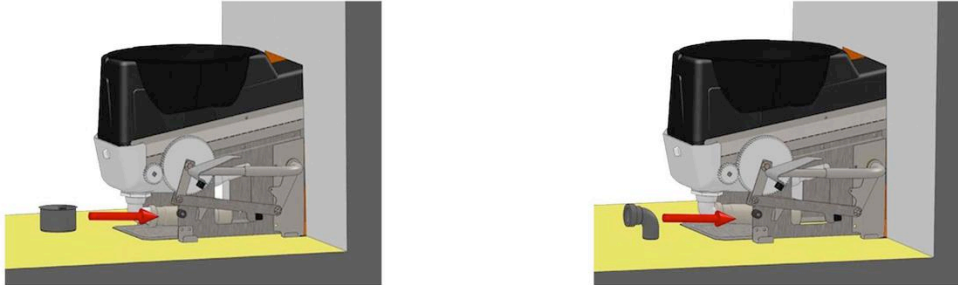
CONNECTING THE URINE EVACUATION HOSE

PUT THE TAMPON WITH THE PVC PIPE (90° ELBOW) INTO THE EVACUATION HOLE

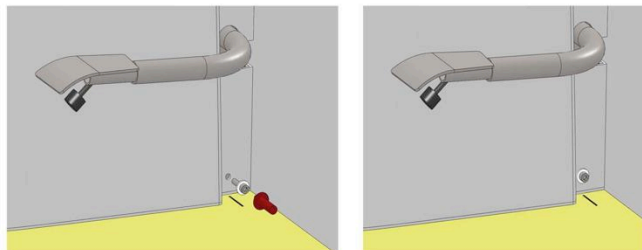
GENTLY SCREW THE BOLTS INTO PLACE THEN WITH THE BTR SERRER, TIGHTEN BY HALF A TURN. DO NOT OVER TIGHTEN
