RDEK ELK RIVER PRIORITY FLOOD AND EROSION MITIGATION SITES

CONCEPTUAL DESIGN REPORT

MAY 2016

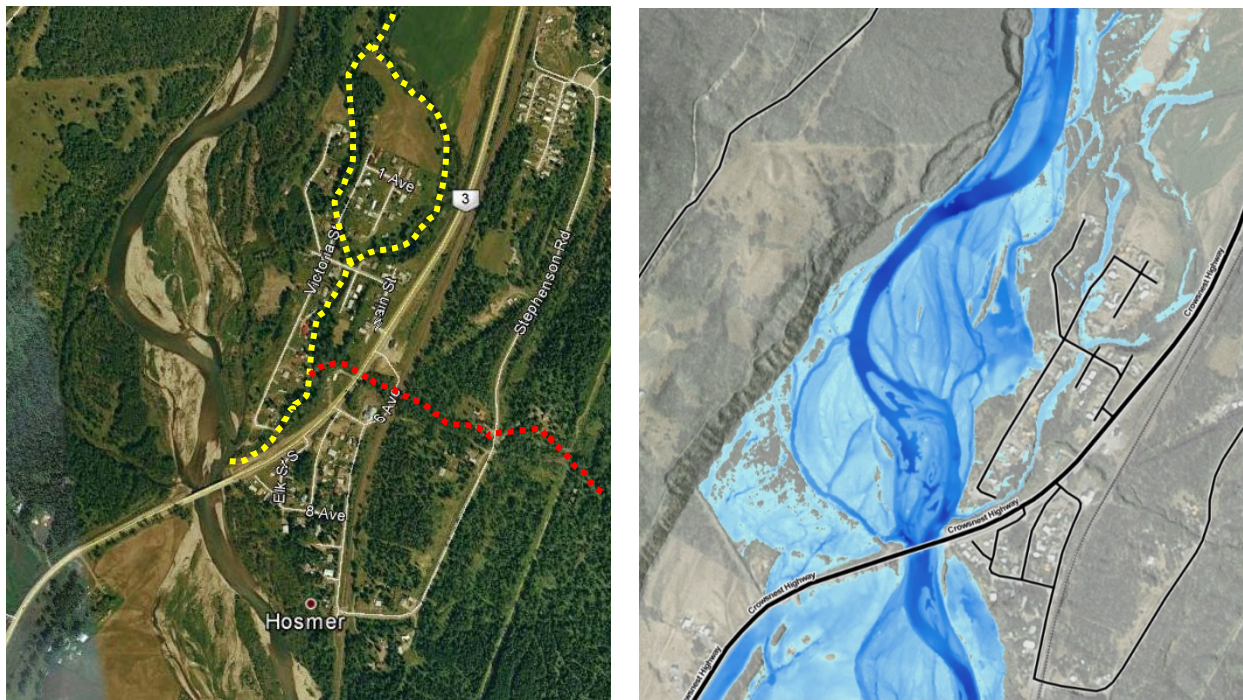
Flooding has historically been an issue for lower Hosmer residents, situated on the west side of Highway 3 in the Elk River floodplain (Figure 6). The cause of flooding is not yet well understood. For this assessment we reviewed air photos taken during the June 2013 flood, results from the flood simulations produced for the Elk River Flood Solutions report, and visited the area during a site survey. It was initially suspected that flooding in lower Hosmer was primarily caused by the Elk River overtopping its banks and occupying the floodplain. However, each line of evidence suggests that Mine Creek is more likely the prime reason for the flooding that occurs. It is also still poorly understood as to what role effect Hosmer Creek and the Elk River aquifer have on localized flooding. It is possible that Hosmer Creek contributes to flooding within lower Hosmer near its confluence with Mine Creek. It is also possible that flooding is the result of a higher alluvial (Elk River) water table elevation. This area of Hosmer shows a very shallow water table (close to the surface) at all times of year.

Figure 5. Hosmer town site at low flow (left) and under simulated inundation during a 1:200 year return period flood event. Yellow dashed line = Mine Creek. Red dashed line = Hosmer Creek. NOTE: This simulation is for visual purposes only; it was developed from a preliminary hydraulic model of the Elk River with results plotted against a Lidar-based Digital Elevation Modelling.

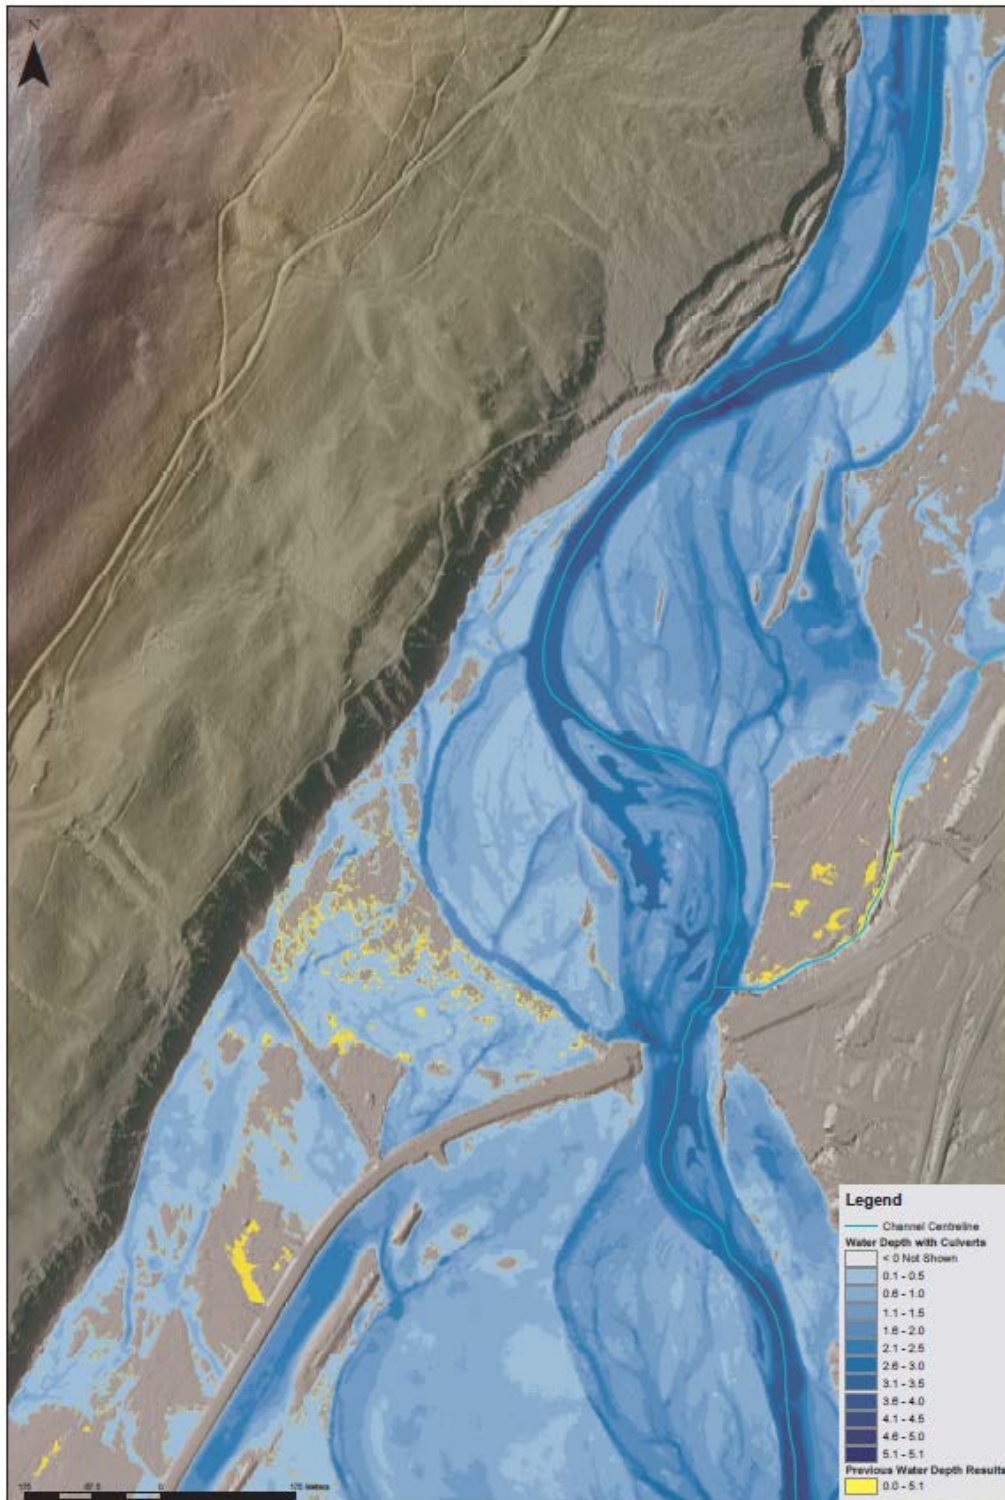
Figure 9. Hosmer townsite area under simulated inundation during a 1:200 year return period flood event. NOTE: This simulation is for visual purposes only. It was based developed from on a preliminary hydraulic model of the Elk River with results plotted against a LiDarLidar-based Digital Elevation Modelling.

Much work remains to properly describe flooding in lower Hosmer and then to assess and compare suitable mitigation options. A key information gap is to accurately identify the cause of flooding so that options can be designed to address specific hazards presented by tributaries, alluvial groundwater, and the Elk River. Potential mitigation options include: diverting flood flows from Mine Creek into the Elk River upstream of lower Hosmer; improving flow through Mine Creek by replacing culverts in lower Hosmer with bridges; and/or, diverting flood flows in Hosmer Creek to the Elk River downstream of the Highway 3 bridge.

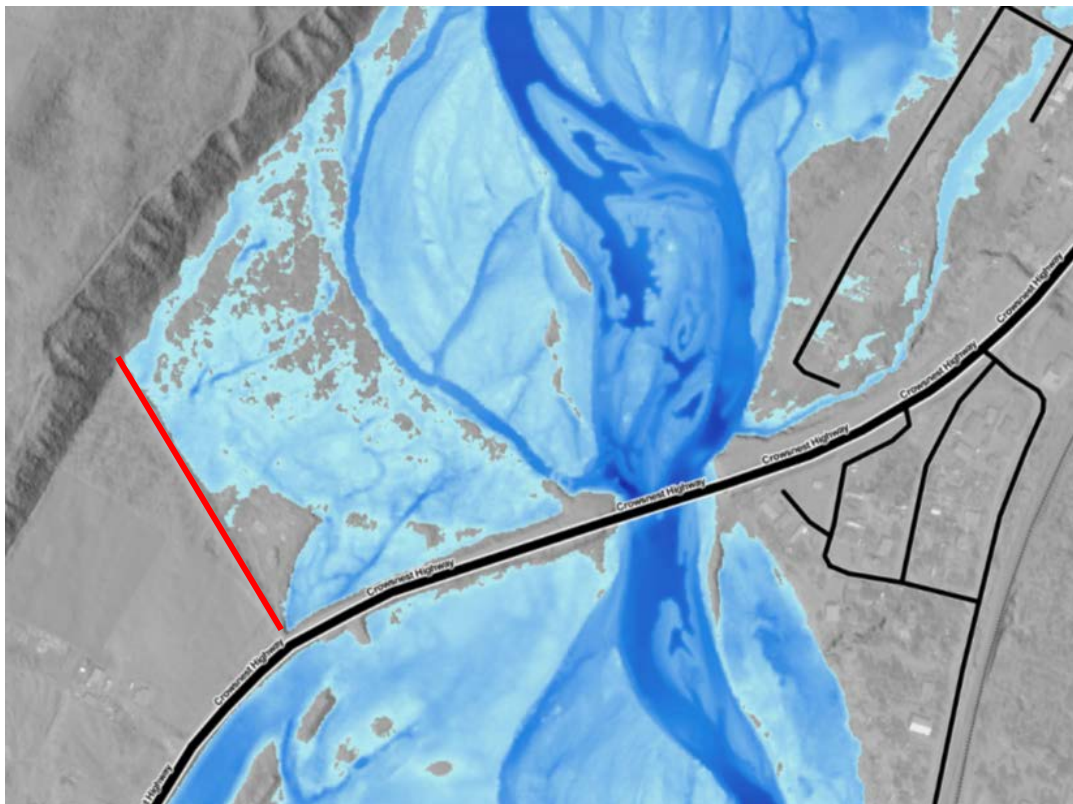
A dike was constructed in 1948 to the west of the Highway 3 Bridge near Hosmer to prevent flooding of private properties to the west of the highway (Figure 10). The area is well-vegetated. Two privately owned lots exist to the north of the dike, between the Elk River and the dike. The dike is currently situated on one of the properties.

This dike partially failed in 2013 (Figure 11) and resulted in some flooding of downstream properties, including a trailer park with multiple residents (Figure 12). Some emergency works were done in 2013 to stop water from flowing over the dike. Reconstructing this dike (set back as far from the river as possible) would help minimize flooding of nearby properties. Relocating the dike to the upstream side of the two properties currently unprotected, would extend protection to additional land. The objective of the RDEK for this site is to reduce the flood hazard for the private lands to the south and possibly north of the dike structure.

Figure 10. Simulated extent of inundation during a 1:200 year flood event. Red line = existing dike. NOTE: This simulation is for visual purposes only; it was developed from a preliminary hydraulic model of the Elk River with results plotted against Lidar-based Digital Elevation Modelling.

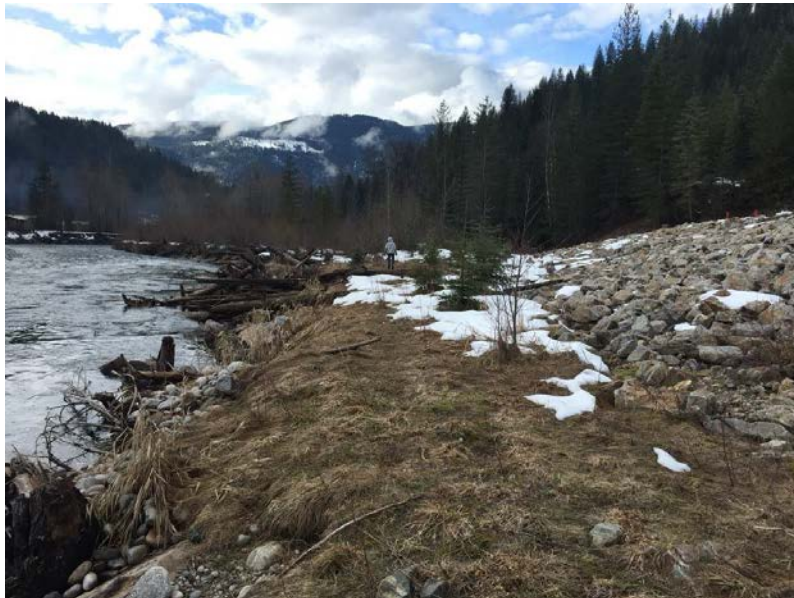
Figure 16. Example of tiered bank protection design with revegetated floodplain incorporated (Ymir, BC).

The concept will be to use a tiered design to offset some of the impact that meeting this objective will have on channel morphology (Figure 16). The tiered design would begin at the streambed with a keyed in toe similar to a traditional rip rap design (Appendix 1). The rock would extend upslope to an elevation near or slightly above bankfull levels, where a floodplain bench would be constructed. We recommend that a 2 m wide floodplain bench is constructed over the entire 150 m site (i.e., the bank nearest the log home on the property), for a floodplain bench of 300 m². The core of the bench would be constructed of coarse material that will not avulse when overtopped by flood flows (approximately 1-in-2 year to 1-in-5 year return). It would be capped with a growing medium capable of supporting vegetation. Planting can be completed as a combination of grass seeding and live staking (e.g., willow and dogwood species). The slope up from the floodplain bench to a design elevation determined by the project engineer would be treated by constructing a vegetated geogrid (Appendix 2). The bank will first be resloped. The slope of this would be determined in subsequent design phases, but typically a final slope of 2:1 is desired. Successive horizontal benches parallel to the stream are excavated where cuttings will be set in. Benches are to be spaced 1 m apart, with the first located at or near the floodplain bench. The number of benches is determined by the bank height. Benches will be spaced at 1 m slope distance. Cuttings are placed on the benches and covered with a thin layer of growing medium. Coconut coir matting is placed in the trench, backfilled and ran upslope to key into the next bench in sequence or a top trench if it is the upper most layer. Live stakes can be used to hold down the jute and to provide vegetation cover. The area is lastly seeded with an applicable grass seed mix. The top of this slope would tie into existing ground, effectively advancing the toe into the stream from its currently location. This concept assumes two brush layers in the geogrid on average.

The intent of this design is to provide a vegetated buffer along the channel, while meeting the objective of limiting further bank erosion. The tiered approach provides immediate protection while allowing the upslope area to become revegetated. One limitation to this approach is that the upslope area will be somewhat vulnerable to erosion immediately following construction, but will improve as vegetation establishes over time.

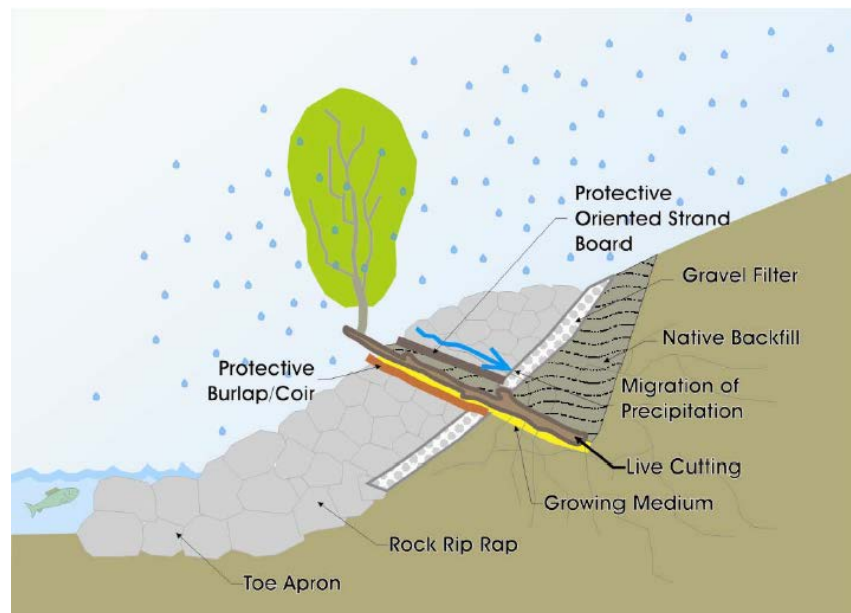
Figure 19. Vegetated riprap concept drawing (AMEC 2012).

Rip rap bank armouring will be installed to protect the toe of slope and bank and for the upper 50 m of the site. We recommend vegetated riprap to reduce the impact of the treatment by providing some habitat value and to improve riprap stability as the shrubs establish overtime (Figure 19). We estimate that the vegetated 50 m along the bank and run 2 m upslope above the bankfull elevation at a slope of 2:1 for a slope distance of 4.5 m. It would be approximately 1.5 m thick. Riprap limits, sizing, and thickness would be confirmed during a hydraulic assessment in subsequent stages. Vegetated riprap is constructed with live cuttings installed as brush layers among the riprap slope. Cuttings are placed in sona tubes filled with a growth medium and protected by a layer of strand board on the upslope side. The proposed design will have two brush layers over the slope of the riprap.

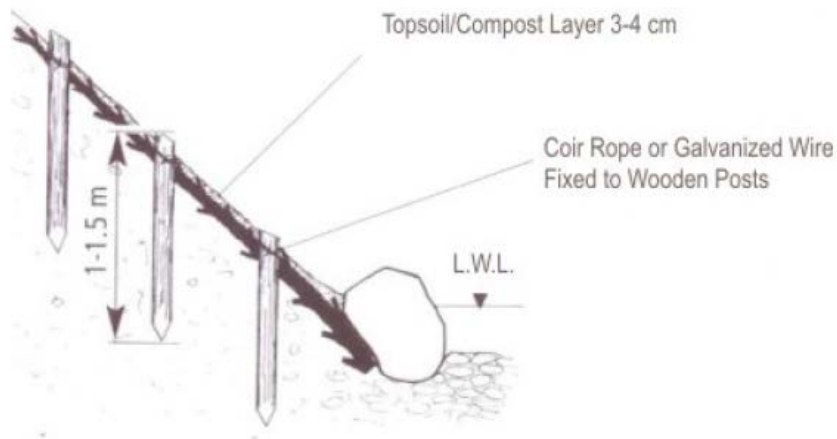
Figure 20. Vegetated riprap concept drawing (AMEC 2012).

The following 150 m of bank downstream from the vegetated riprap will be treated with a combination of a riprap toe (Appendix 2) and a brush mattress (Figure 20) to protect the slope. The riprap toe will be a keyed in toe similar to a traditional rip rap design (Appendix 1). The rock extends upslope to an elevation determined by the Project Engineer. This is typically higher than bankfull flood stage, but not as high as traditional protection (e.g., 1 in 200 year flood return). A brush mattress will be installed upslope from the riprap by placing a layer of interlaced live stems on the exposed bank. The live stems are long enough so that the bottoms are keyed in behind the riprap and extend to the water table. They are also long enough to cover the exposed face of the bank. Cuttings are then covered with a layer of soil, coconut coir, and secured to the bank by a combination of pins driven into the bank and horizontal lengths of rope between pins.

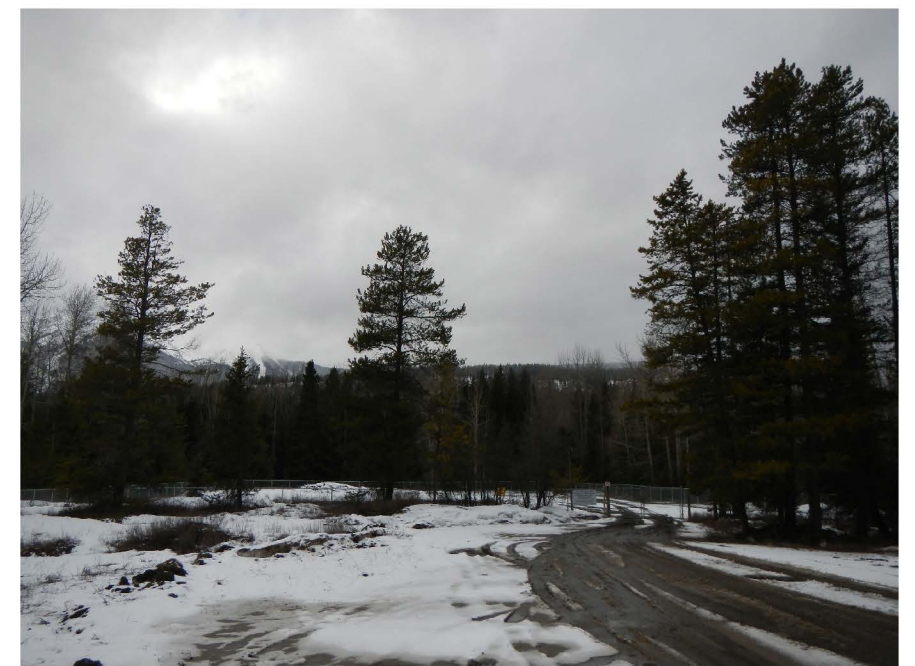
PHOTO 1: VIEW OF ACCESS ROAD AND PONDS FROM HIGHWAY 3.

- 1) **OPTION A - POND RELOCATION**
 - A) REMOVE FENCING AND EXCAVATE MATERIAL AS DIRECTED BY ENVIRONMENTAL ASSESSMENT.
 - B) CONTOUR POND BERMS AND ACCESS ROAD MATERIAL.
 - C) APPLY COVER AS DIRECTED TO PROMOTE REVEGETATION.
 - D) REVEGETATE FOOTPRINT.
- 2) **OPTION B - DIKE**
 - A) CONSTRUCT DIKE TO DESIRED FLOOD ELEVATION.
 - B) SURFACE OUTBOARD FACE WITH VEGETATED RIPRAP.

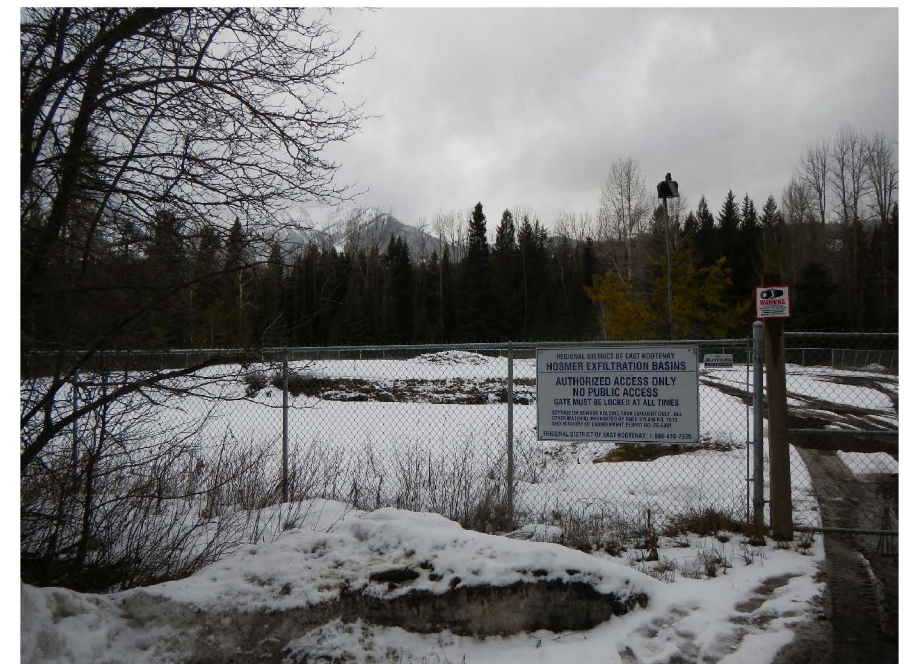
PHOTO 2: VIEW OF PONDS FROM ACCESS GATE.

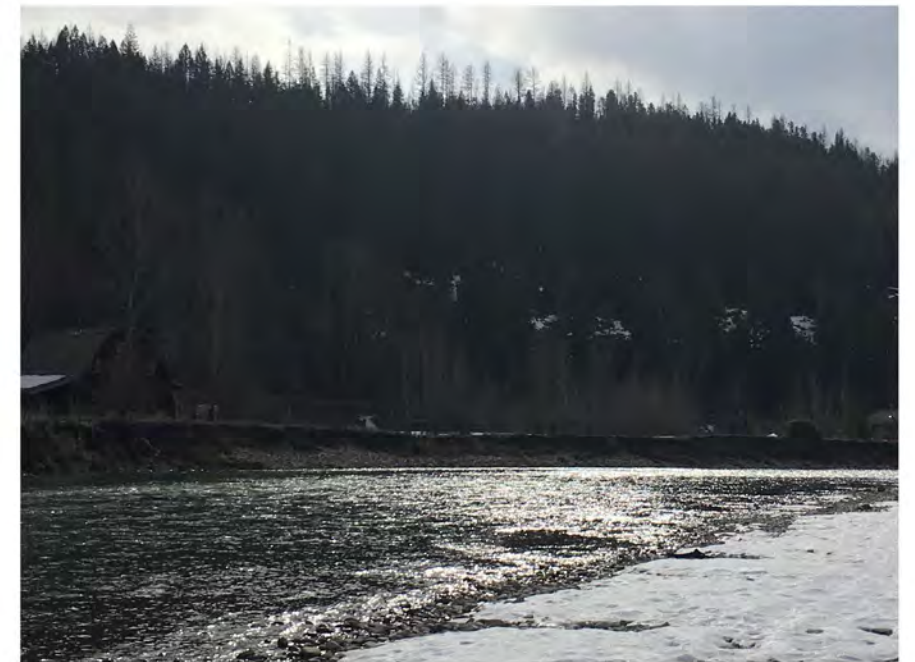
PHOTO 2: DOWNSTREAM VIEW OF BARN AND SECOND DWELLING FURTHER DOWNSTREAM ON SUBJECT PROPERTY.

- 1) INSTALL RIPRAP TOE AT NEW ALIGNMENT INTO THE CHANNEL TO CREATE FINAL DESIRED SLOPE TIE-IN TO EXISTING BANK.
- 2) BRING ROCK TOE UP TO FLOODPLAIN ELEVATION.
- 3) CONSTRUCT TWO METER FLOODPLAIN BENCH, CAP WITH SOIL, SEED AND PLANT.
- 4) CONTINUE RIP RAP UP SLOPE AT 2:1 TO FINAL ELEVATION.

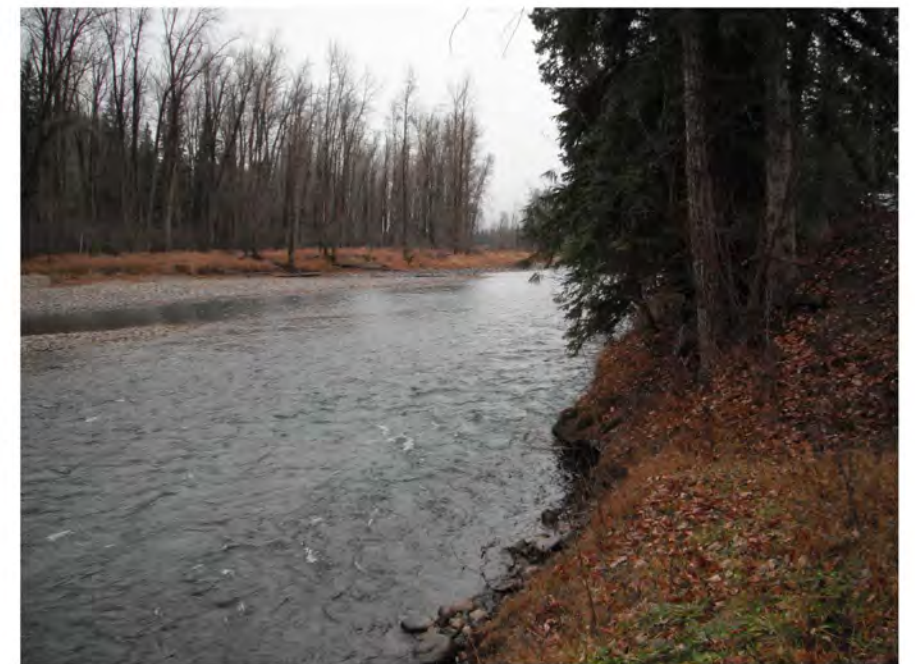
PHOTO 2: DOWNSTREAM OF EXISTING RIPARIAN VEGETATION WITHIN THE SITE.

- 1) INSTALL RIPRAP TOE TO PROTECT THE RIGHT DOWNSTREAM BANK FROM EROSION.
- 2) CONSIDER TIERED BANK TO INCREASE FLOOD CAPACITY AND PROVIDE VEGETATED FLOODPLAIN BENCH.
- 3) INSTALL ROCK SPURS OFF THE TOE OF THE RIPRAP BANK MOVE THE THALWEG TOWARDS THE CENTER OF THE CHANNEL AWAY FROM THE RIGHT DOWNSTREAM BANK.
- 4) VEGETATE THE TOP OF THE ROCK PLATFORM WITH WILLOW TO PROVIDE FISH AND WILDLIFE BENEFITS.
- 5) ATTEMPT TO MAINTAIN AS MUCH OF THE EXISTING VEGETATION AS IS POSSIBLE.

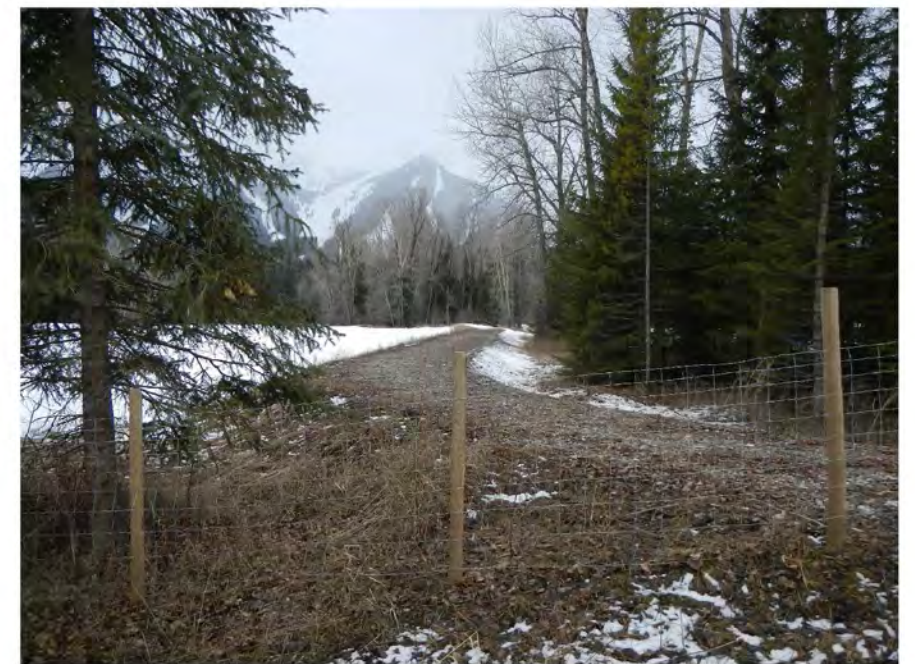
PHOTO 2: DOWNSTREAM VIEW OF EXISTING BERM CONSTRUCTED POST-2013.

- 1) CONSTRUCT TIERED BANK ON LEFT DOWNSTREAM BANK. INSTALL RIP RAP ARMOURING ALONG THE LOWER SECTION OF THE BANK. CONSTRUCT A FLOOD BENCH ABOVE THIS AND VEGETATE. FOLLOW UP WITH A SLOPED BANK THAT MAY BE ROCK ARMOURING WITH A SOIL/VEGETATION COVER.
- 2) PROJECT FOOTPRINT SHOULD EXTEND UPSTREAM AND TIE INTO CPR RIP RAP WORK.
- 3) THE VEGETATION WILL PROVIDE RIPARIAN BENEFITS TO FISH AND WILDLIFE, AND PROVIDE BANK STABILITY.
- 4) CONSIDER ADDING SPURS TO DIRECT FLOW TOWARDS THE CENTER CHANNEL, AWAY FROM THE TOE OF THE RIP RAP AND VEGETATED AREA.
- 5) ENSURE THE DESIGN MINIMIZES DOWNSTREAM IMPACTS ON THE HIGHWAY.
- 6) ENSURE THAT THE WORKS MAINTAIN THE EXISTING COTTONWOOD STAND ALONG RIVER CORRIDOR.

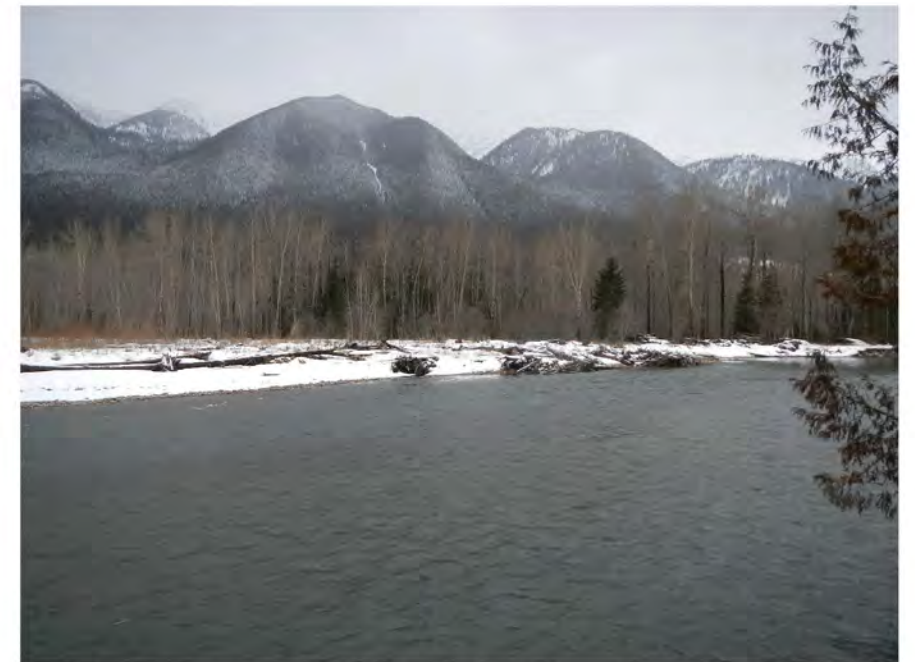
PHOTO 2: CROSS-CHANNEL VIEW OF SUBJECT GRAVEL BAR ON LEFT BANK.

- 1) INSTALL ADDITIONAL LWD JAMS TO ENHANCE EXISTING WORK ALREADY DONE AT THE SITE.
- 2) CONSIDER ROCK SPURS.
- 3) AVOID LWD AND/OR VEGETATION REMOVAL ON OPPOSITE SIDE OF THE ELK RIVER (I.E., WEST SIDE).
